Black Canyon Hydroelectric Project
FERC Project No. P-14110
Fish Passage Report
February 2014

Prepared for
Black Canyon Hydro, LLC
3633 Alderwood Avenue
Bellingham, WA 98225

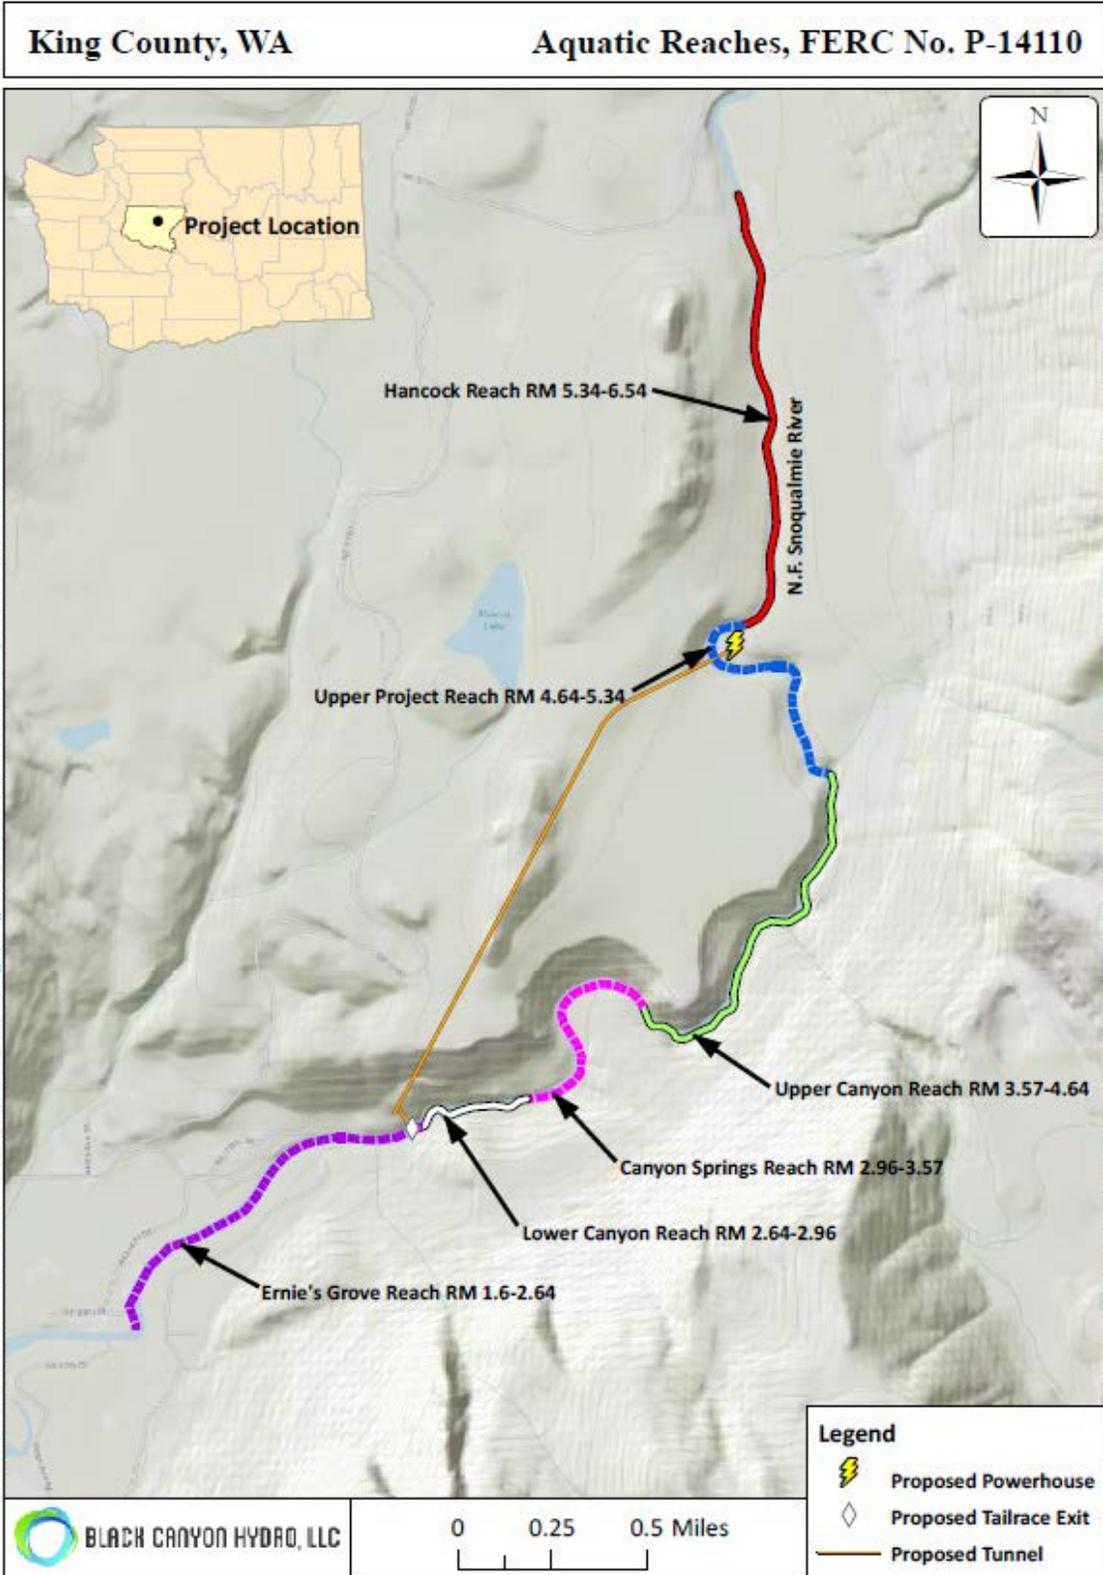
Figure 3 - Aquatic Reaches

The five-mile study reach has six distinct segments where the gradient, substrate and habitat composition of pools, riffles, glides and cascades are different. The Project Reach is subdivided into the lower canyon, Canyon Springs, upper canyon, and upper project segments (Figure 3). Each segment is listed below in Table 2 with length, slope, and habitat characteristics.

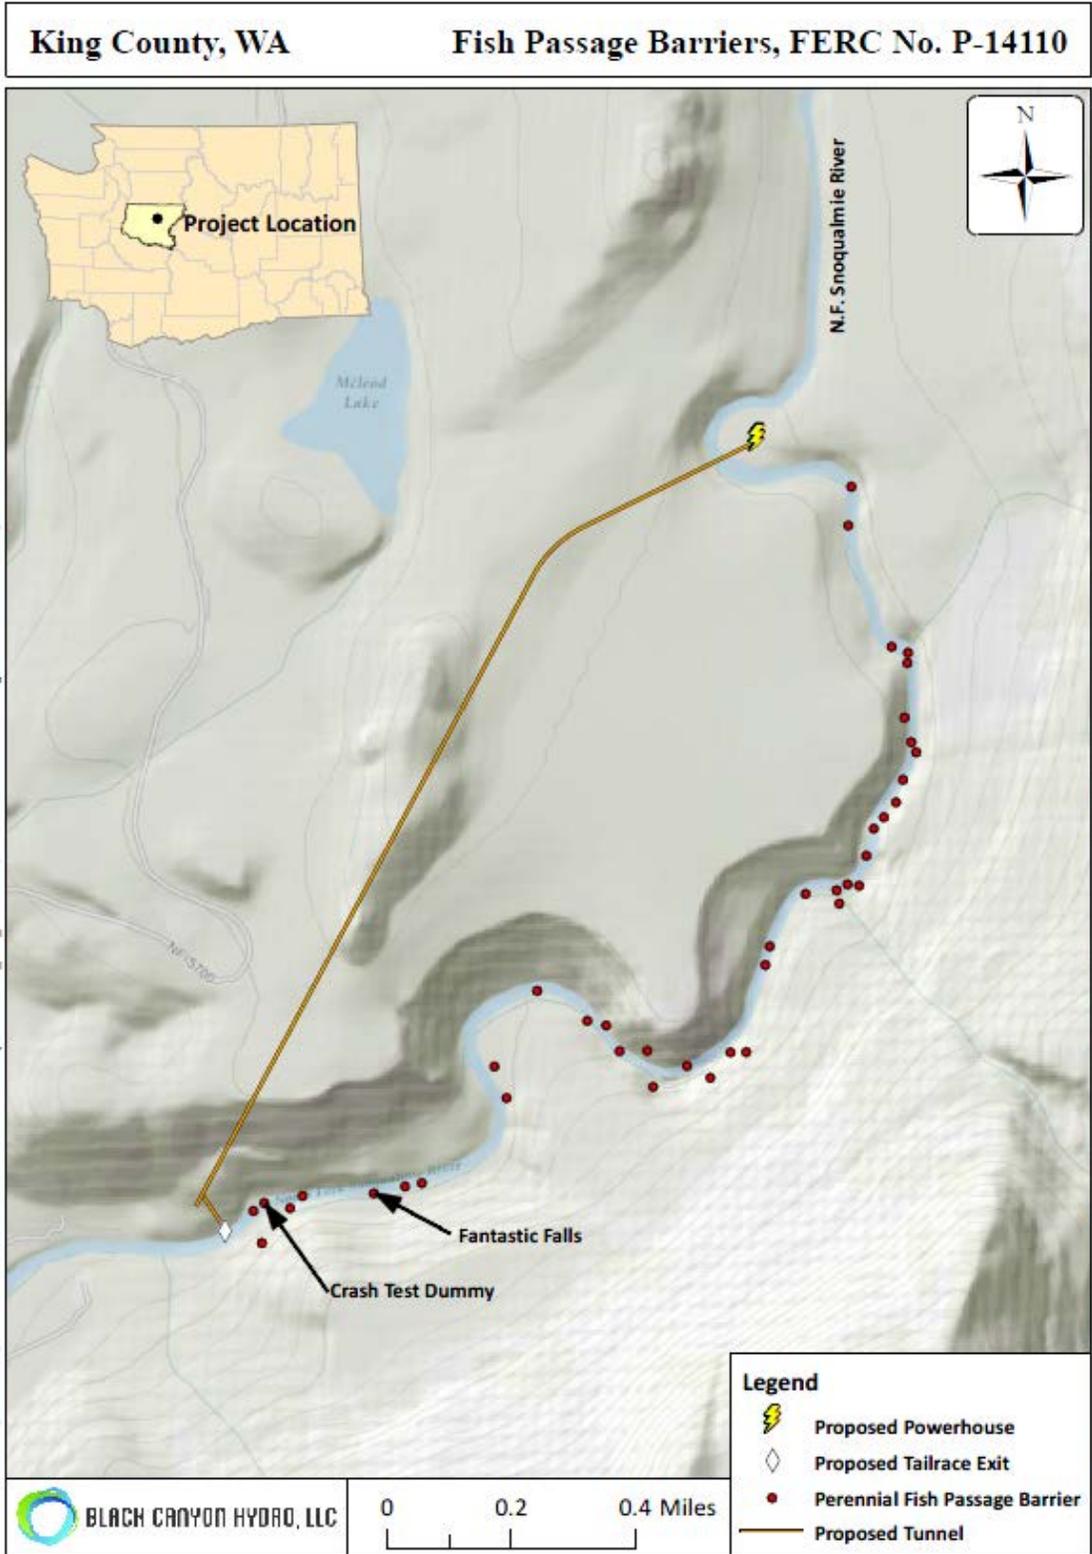
Figure 4 - Fish Passage Barriers Map

Snoqualmie River Game Fish Enhancement Plan (Thompson et al. 2011). Perennial passage barriers prevent upstream fish passage due to single falls or a series of cascades chutes and plunge pools which cause water velocity that exceeds the fish burst speed and create turbulence that entrails air into the water that decreases the swimming ability of fish. Although these barriers do not necessarily fit the WDFW criteria of a single 12-foot falls or a reach with a gradient >20% for a distance of 525 feet (WDFW 2000) that are barriers to anadromous salmon, the identified barriers in the Project Reach present a very high degree of difficulty for resident trout to migrate upstream. Trout may move a short distance upstream to find more favorable rearing habitat but, extreme high flow events likely move fish downstream. The net movement of the trout population is downstream. In addition, spawning gravel is very sparse in the Project Reach and although spawning may occur, recruitment of trout is likely from fish moving from upstream river segments and tributaries. Figure 5-Figure 8 are representative of the perennial barriers in the Project Reach; ‘Crash-test dummy Falls’ is located at RM 2.7, downstream of Fantastic Falls, and is a barrier to largescale sucker and mountain whitefish. Fantastic Falls is a 16-foot vertical falls and is barrier to resident trout located at RM 2.89.

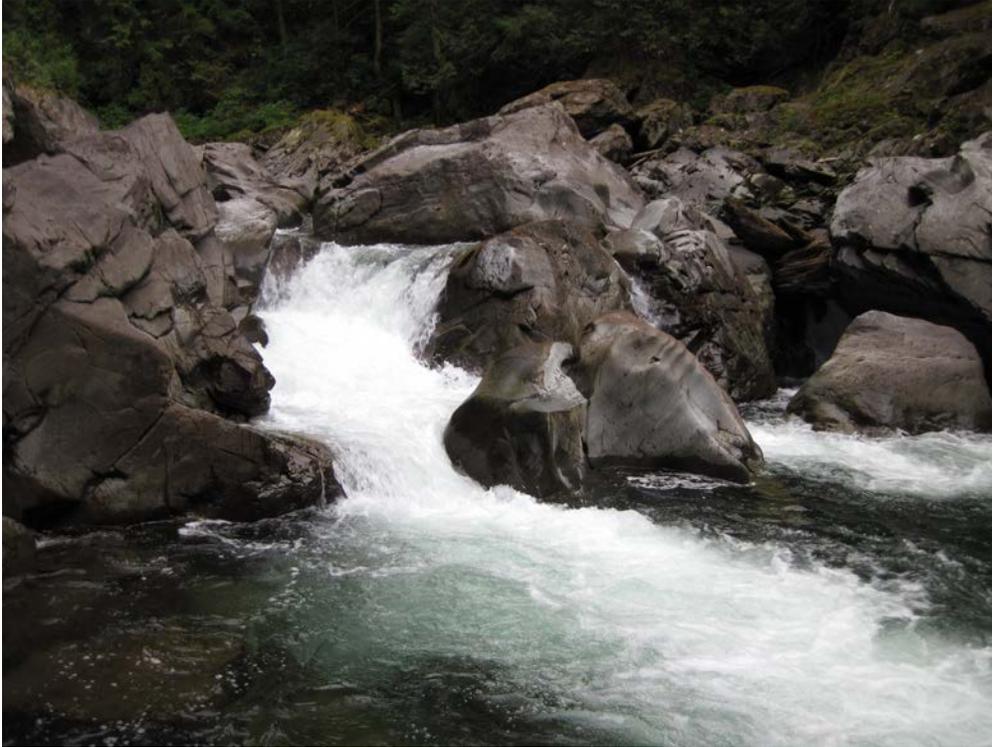
Figure 5 - Crash-test dummy Falls at RM 2.70 blocks upstream passage of largescale sucker, mountain whitefish and likely resident trout.

Downstream of ‘crash test dummy falls’ and Fantastic Falls, largescale sucker and mountain whitefish were also observed, and native sculpin were observed throughout the study area.”

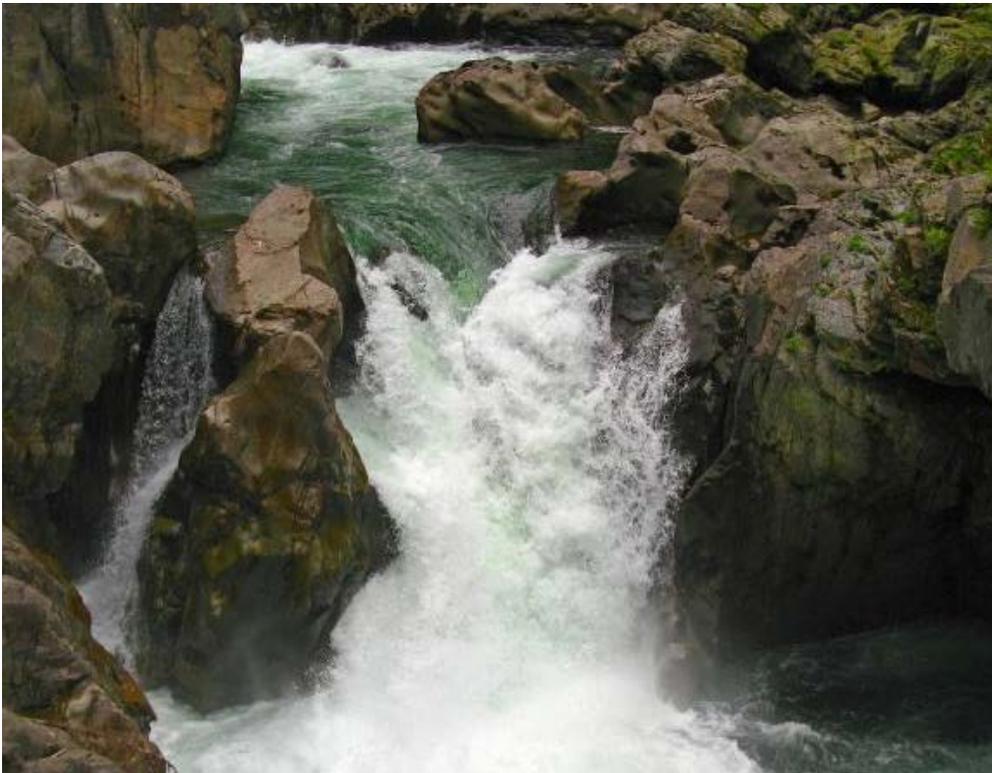
Figure 6 - Fantastic Falls at RM 2.89 blocks upstream passage of resident trout.

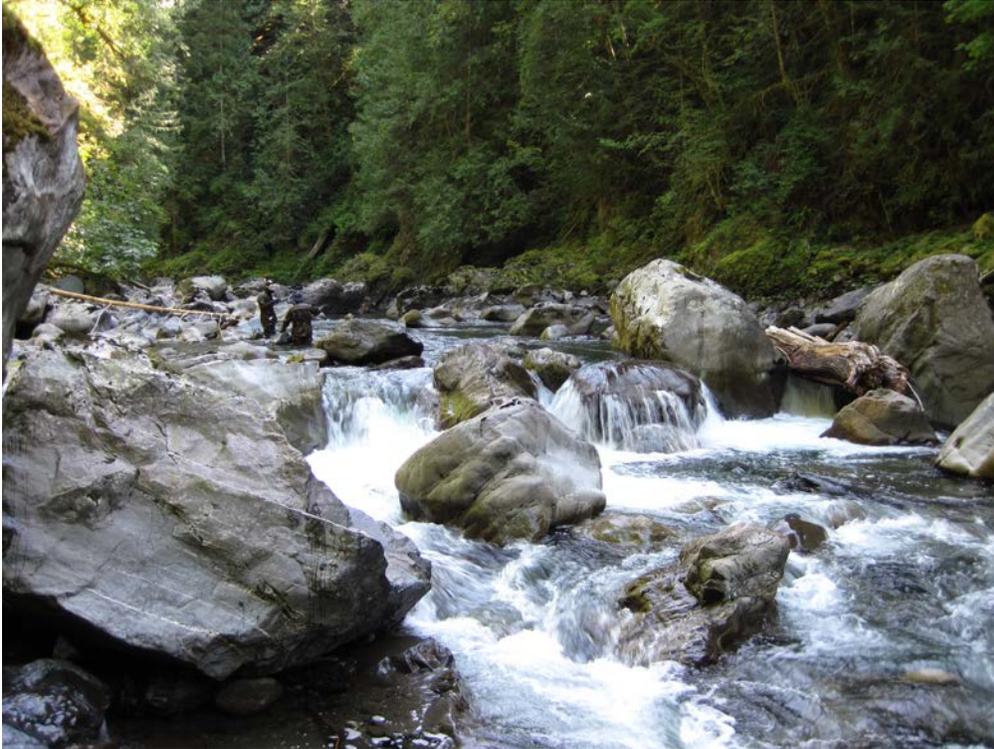
Figure 7 - Typical fish passage barrier in upper canyon. August 13, 2013, flow=70 cfs at BCH upper gage.

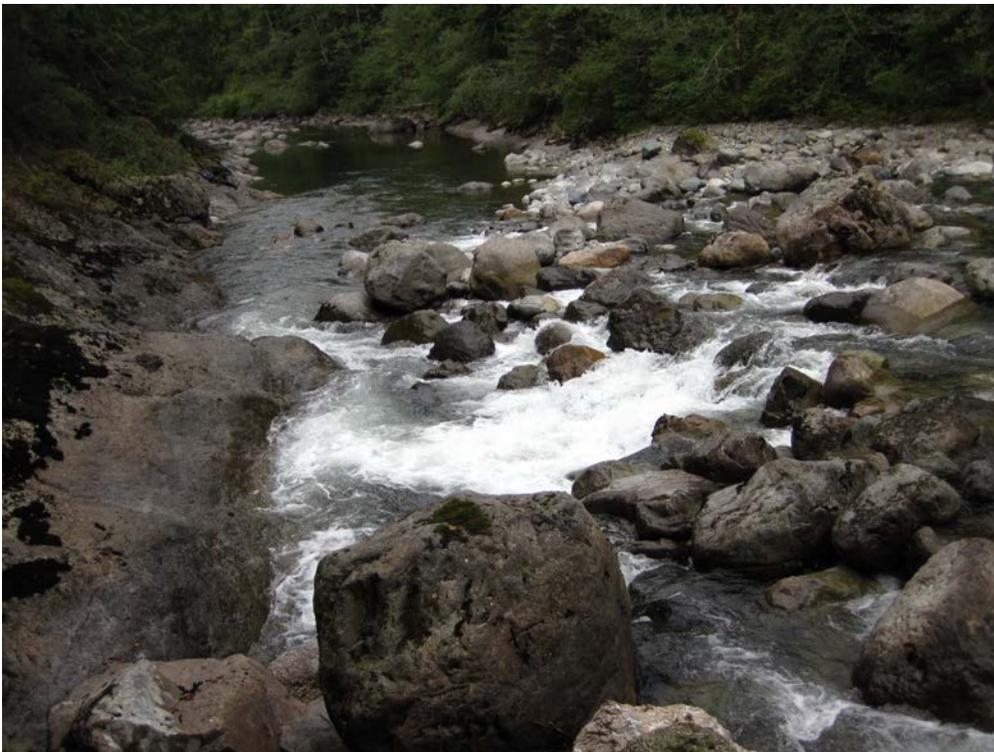
Figure 8 - Cascade in upper project reach identified as a perennial fish passage barrier at RM 5.0. August 14, 2013, flow=65 cfs at BCH upper gage.

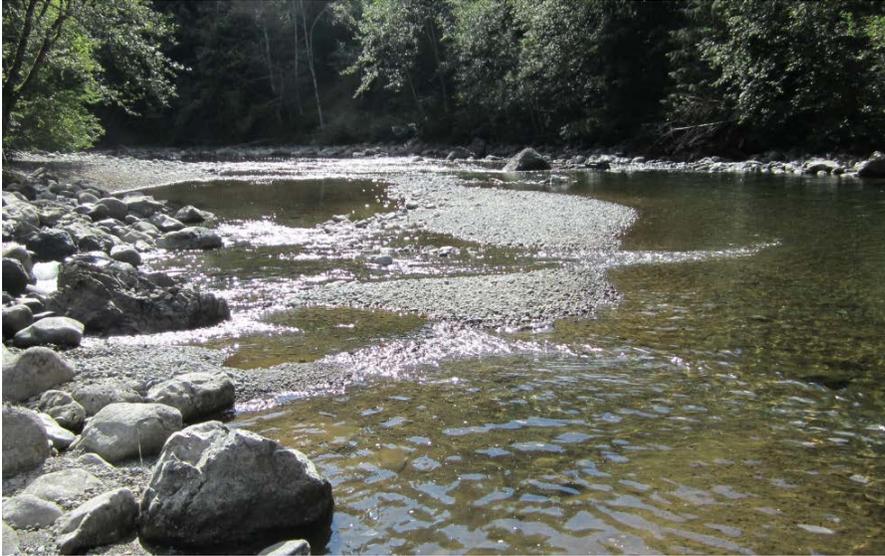
Figure 9 - Photo of intake Alternative “A” site, RM 5.23

Site conditions: Access to the Alternative A site is possible with an extension of an existing logging road on the east side of the river. A steep slope exists on the west bank of the river at the Alternative A site. This slope has the possibility of being unstable. Further analysis would need to be performed to completely understand the geology of the slope. The intake is sited on the inside of a river bend potentially creating problems with sediment build up in front of the intake structure. The intake site is predominantly sited within the flood way and would require significant grading and structural walls to ensure the maintenance platform is sited above the flood stage. During a flood the intake site could become isolated due to the location of the natural fishway bypass system.

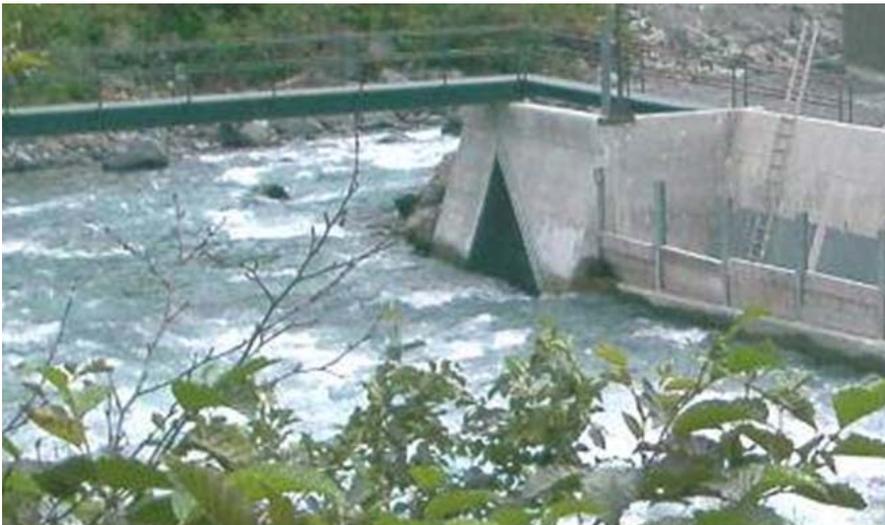
Figure 10 - Photo of rubber dam in deflated position

Water impoundment would be necessary to create a reliable pool elevation, and adequate elevation differential required to adequately “sluice” sediment and debris through the screen bay. An inflatable rubber dam provides both a reliable pool and required elevation differential across the structure. The inflatable rubber dam is also able to deflate under various flow conditions to allow sediment and debris to pass during high flow events. For typical rubber dam photos see Figure 10 - Photo of rubber dam in deflated position and Figure 11 - Photo of rubber dam inflated position.

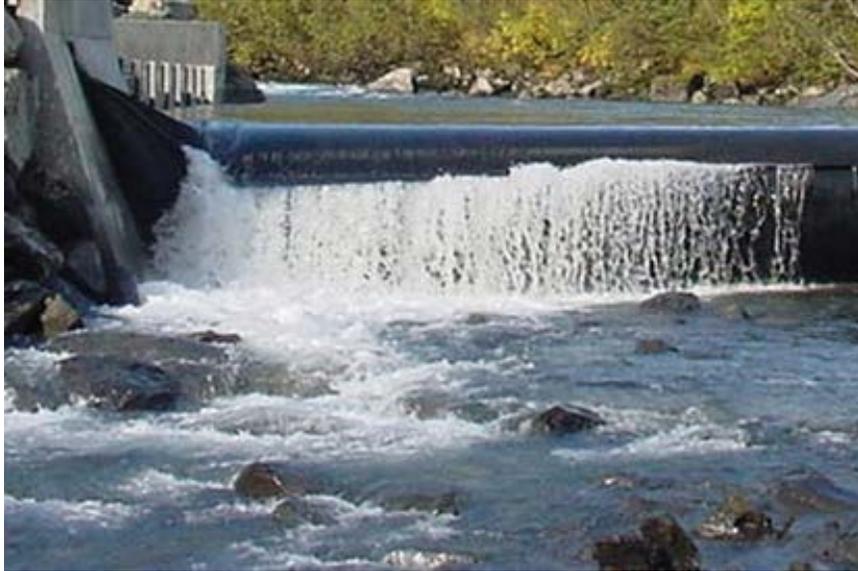
Figure 11 - Photo of rubber dam inflated position

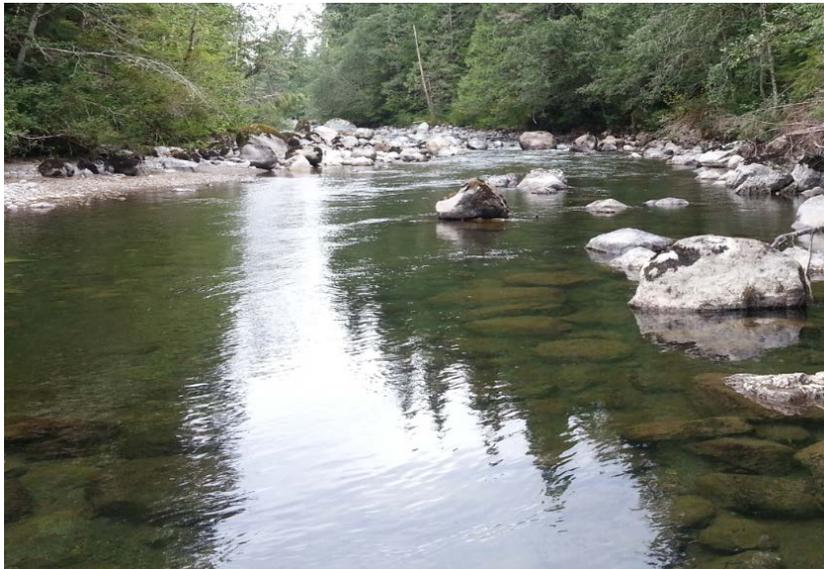
Figure 12 - Photo of alternative "B" site, RM 5.39

Without a large impoundment structure it was determined from site topography and design considerations that the Intake Alternative B location did not have adequate river gradient needed to move debris and sediment through the screen structure using passive flow. A mechanical debris removal system would be required to move sediment and debris from the screen bays for Alternative B. The siting on the west bank is also on an inside river bend which would make maintaining an adequate pool depth difficult. Therefore it has been determined that Alternative B will no longer be considered a viable intake alternative.

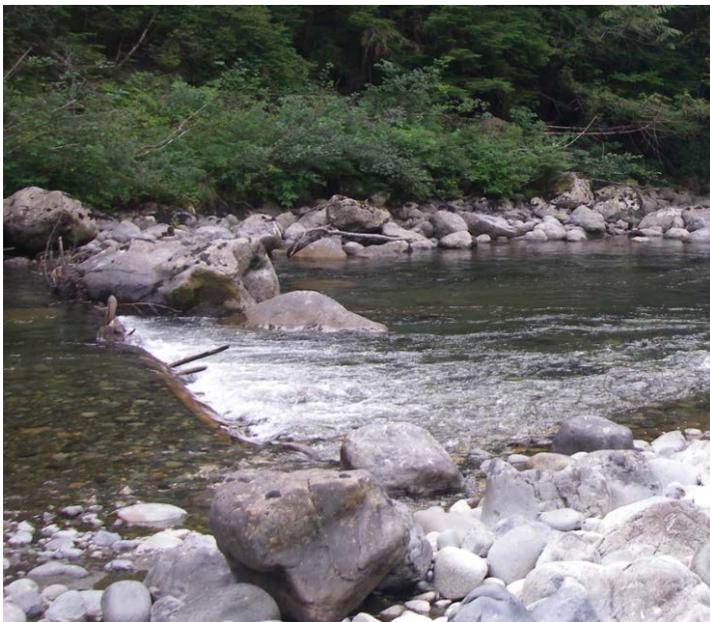
Figure 13 – Photo of proposed alternative "C" location, view of west bank, RM 5.3

After researching the viability of Alternative B engineers continued analyzing available topographic information in the vicinity off the Alt B site and discovered adequate elevation differences across a natural point bar feature near river mile 5.3 downstream of the Alternative B site. This revised location using similar concepts to the Alternative B proposal is called Alternative C. The Alternative C location is near the end of an outside river bend which improves the ability to maintain adequate flow depth and flow direction at the point of diversion, see Figure 13.

the river approximately 475 feet upstream of the proposed Alternative A intake site. This alternative would consist of the following new facilities: (1) A control sill to control the normal water surface elevation and consistent river bed elevation for a side channel bulk-water intake. The control sill would consist of a concrete weir with boulders inset on the surface over top of a cutoff wall of sheet pile driven to a depth of approximately 10-20 feet, or to refusal, to capture hyporheic flow. The sill would be at the newly established grade of the river bed and would allow uninterrupted water flow through a re-profiled river as a roughened channel series of step pools, riffles, and boulder weirs that would allow upstream and downstream fish passage. (2) An intake structure with a coarse trashrack, jib crane, sluiceway, and radial gate with sluiceway would be located on the east bank of the river, diverted water would be conveyed through; (3) an open channel to a; (4) head gate control structure and into a; (5) fish and debris screening structure. Fish screens in this structure would be mounted vertically, and would have; (6) an automated mechanical wiper system to clear the screen of debris. Screened water would then flow through a; (7) 10-foot-diameter, 450-foot tall vertical penstock; to an underground powerhouse. (8) An approximately 8,600-foot long, 12-foot-diameter tail race tunnel would convey water back to the river near RM 2.6 in the upstream section of the Ernie's Grove reach. (9) Access to the intake site via an existing logging road with an additional 400 feet of new roadway. (10) Fish and debris would be screened and bypassed back into the river using 2 screen bays each consisting of two walls of vertical fish screens in an approximately 6-foot deep pool with a V-shaped configuration (V-screen). Drawing numbers 120 and 121 illustrate Intake Alternative C at river mile 5.3.

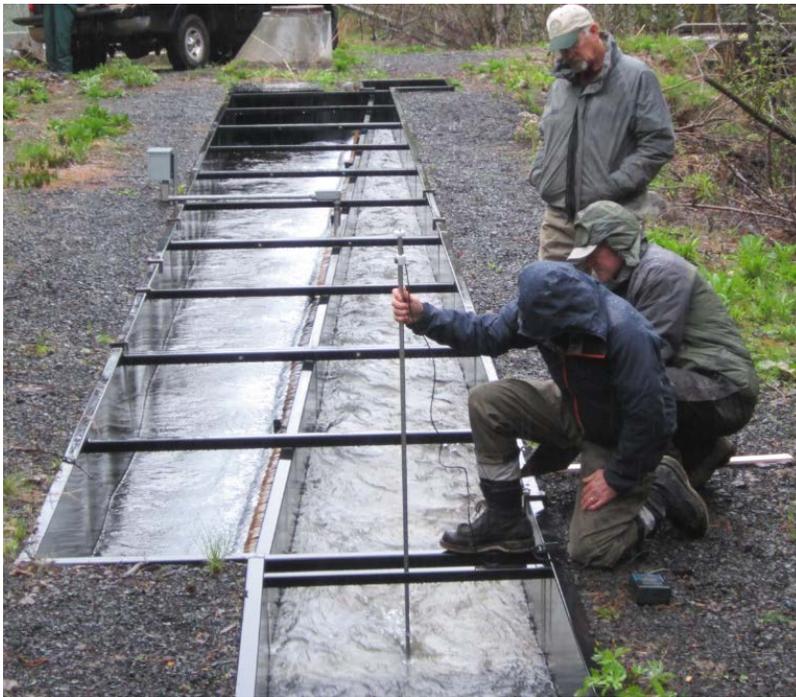
Figure 14 – Photo of sampling water velocity on the Deadpoint Creek screen, OR

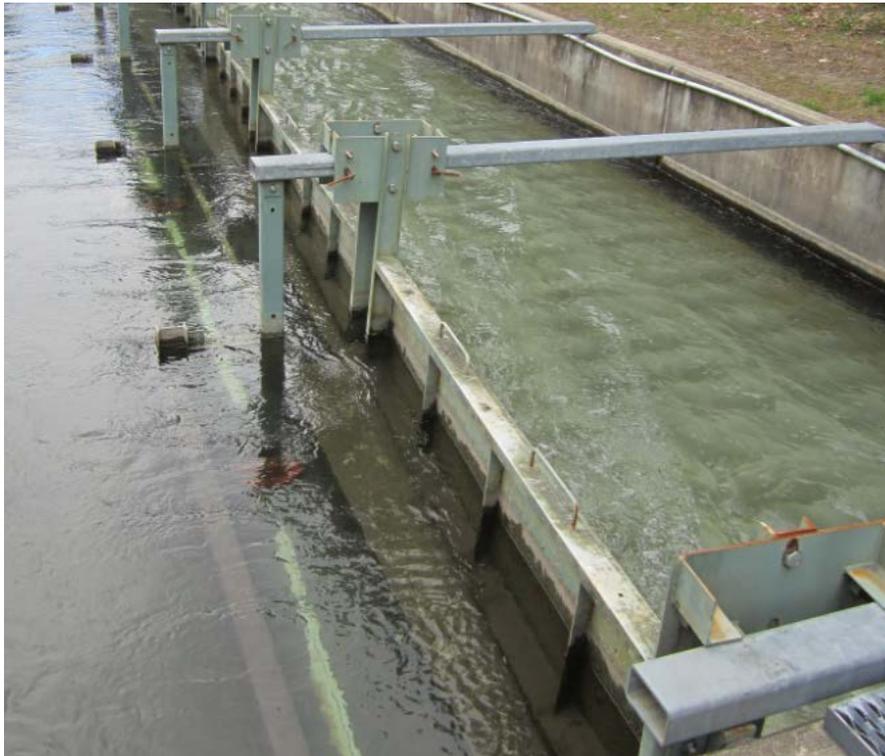
Figure 15 – Photo of Davenport screen, Hood River OR

One of the larger FCA operating screens called the Davenport Screen located on a canal diversion on Hood River, installed in 2002. The capacity of this screen is 80 cfs, see Figure 15. Hood River also has Anadromous/ESA species present. Diverted water is used for irrigation and hydroelectricity. Project partners included Confederated Tribes of the Warm Springs, BPA, ODFW, USFW, NOAA Fisheries, Hood River Watershed Group, and Anderson Perry & Associates.

The screen was designed to be adjustable for experimentation and was designed to be retro-fit with an air burst cleaning system if deemed necessary. Once the screen was operational, it was proven that the air burst cleaning system was not necessary. A monitoring plan for the newly constructed Davenport Screen was created by Farmers Irrigation District in February of 2003. Biological testing was performed by Richard Craven of Craven Consulting Group in the spring of 2003. Craven's report was completed in July of 2003, showing a very high level of protection for species of concern. Biological test and monitoring reports for the Davenport screen are provided in the appendices.

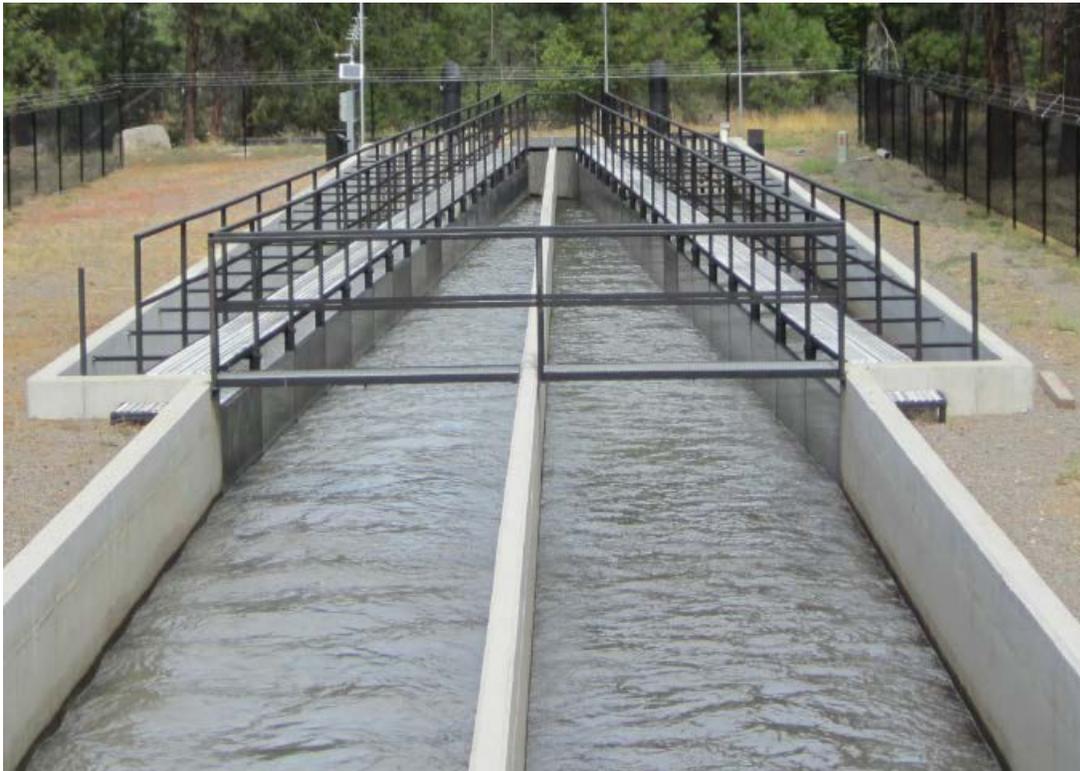
Figure 16 – Photo of Whychus Creek screen, Sisters OR

The screen consists of two 80 cfs horizontal screen bays in parallel that result in a net flow of 160 cfs. See Figure 16 – Photo of Whychus Creek screen, Sisters OR. Each screen bay is approximately 10 feet wide by 160 feet in length. In comparison the

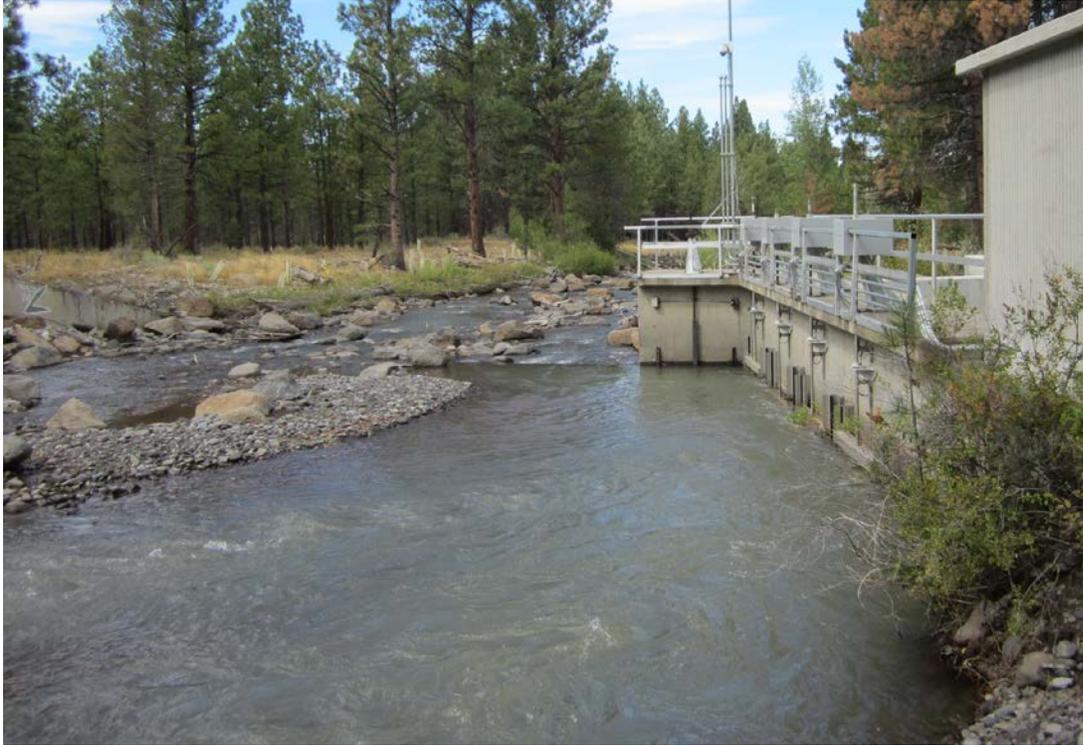
Figure 17 – Photo of Whychus Creek intake, Sisters OR

The Whychus Creek project also has a concrete cut off wall and re-profiled roughened channel downstream of the diversion. Figure 17 and Figure 18 are photos of the diversion and roughened channel. The Whychus Creek project provides a great example of an engineered roughened channel on an Anadromous stream that is currently operating and being monitored.

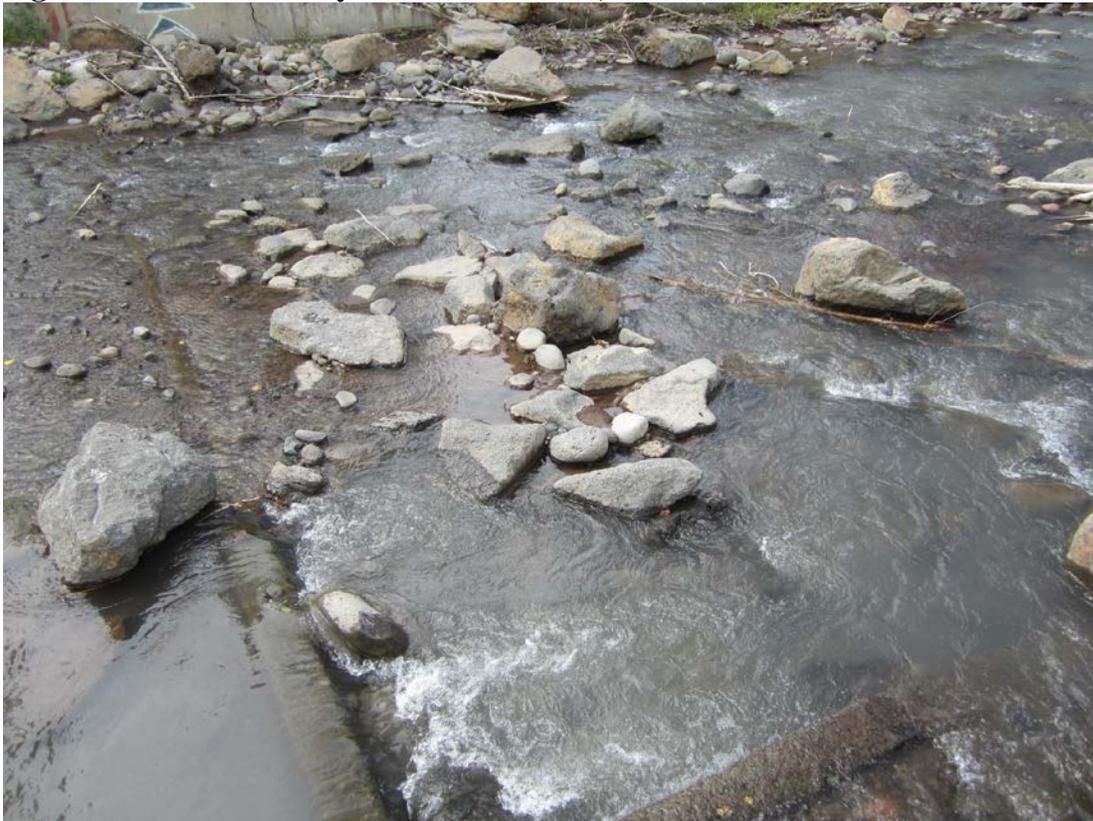
Figure 18 - Photo of Whychus Creek, Sisters OR, at the existing diversion with an engineered roughened channel downstream of the diversion.

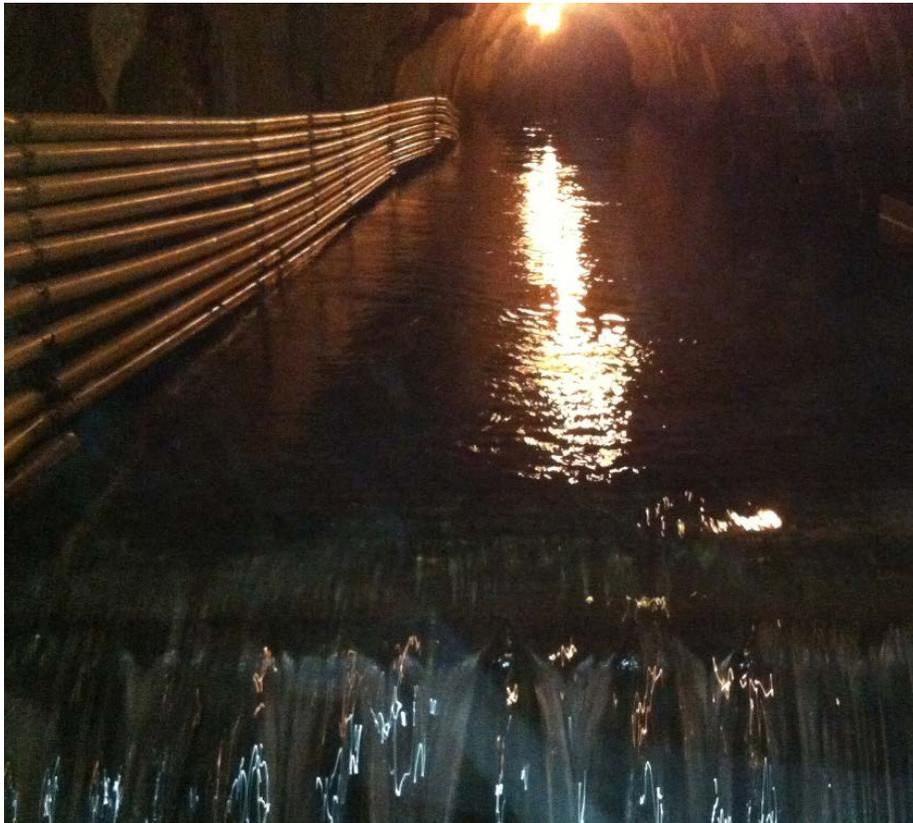
Figure 19 – Photo of Twin Falls Hydro, horizontal fish screen

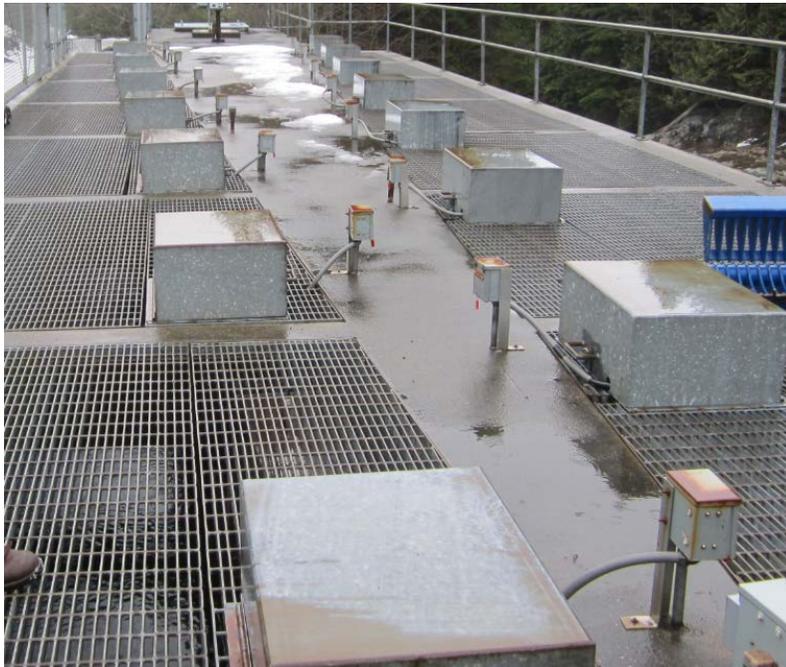
Figure 20 – Photo of Weeks Falls Hydro, vertical screens

Engineering staff also visited the Weeks Falls Hydroelectric site. The project is operated by the Enel Group using the same operator as the Twin Falls project. The Weeks Falls Hydroelectric project is located downstream of Twin Falls on the South Fork of the Snoqualmie River. This project is also located upstream of Snoqualmie Falls and no Anadromous species are present. Flow and debris loading are very similar to the Twin Falls project. Week Falls uses motorized vertical traveling screens. The cover of the screen facility precluded close observation of the screen operation, see Figure 20. The operator of both Twin Falls and Weeks Falls clearly preferred the operation of the Twin Falls horizontal screens over the Weeks Falls vertical traveling screens. The operator stated that the horizontal screens take significantly less time to maintain versus the vertical screens. The project does not provide for upstream passage as the diversion is sited at the top of Weeks Falls.

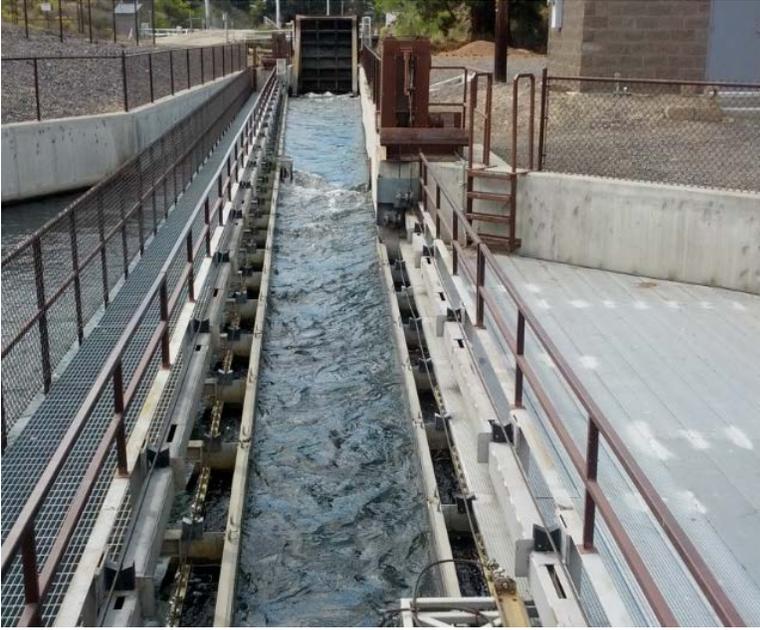
Figure 21 – Photo of Pilot Butte screen, Deschutes River OR

Other vertical plate screens visited by engineering staff were the Pilot Butte Screen (500 cfs) located in Bend Oregon on the Deschutes River, and the Wapatox Screen (450 cfs) on the Naches River in Washington. Both are on Anadromous waterways and use automated traveling screen cleaners to help manage debris. Pilot Butte is managed by the Central Oregon Irrigation District and Wapatox is managed by the U.S. Bureau of Reclamation. The components used for either screen facility are similar and meet NMFS criteria for fish screening. Elements of each project could be used for the Black Canyon Hydroelectric project for the Intake Alternative C scenario.

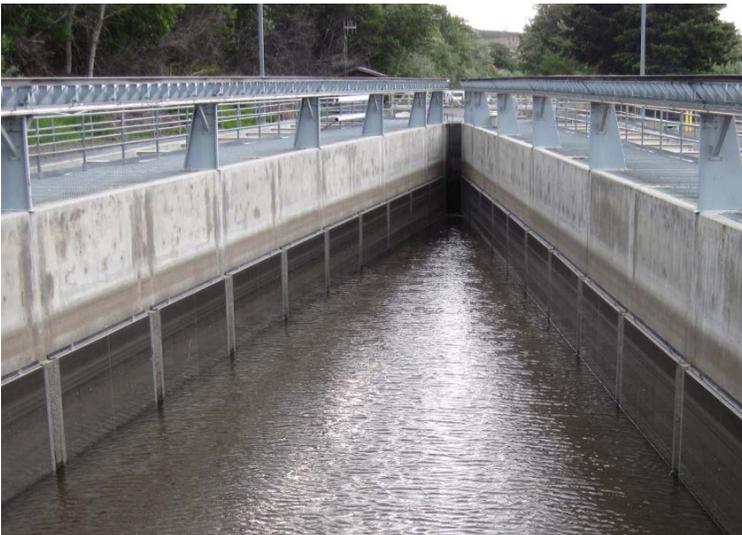
Figure 22 – Photo of Wapatox screen, Naches River WA

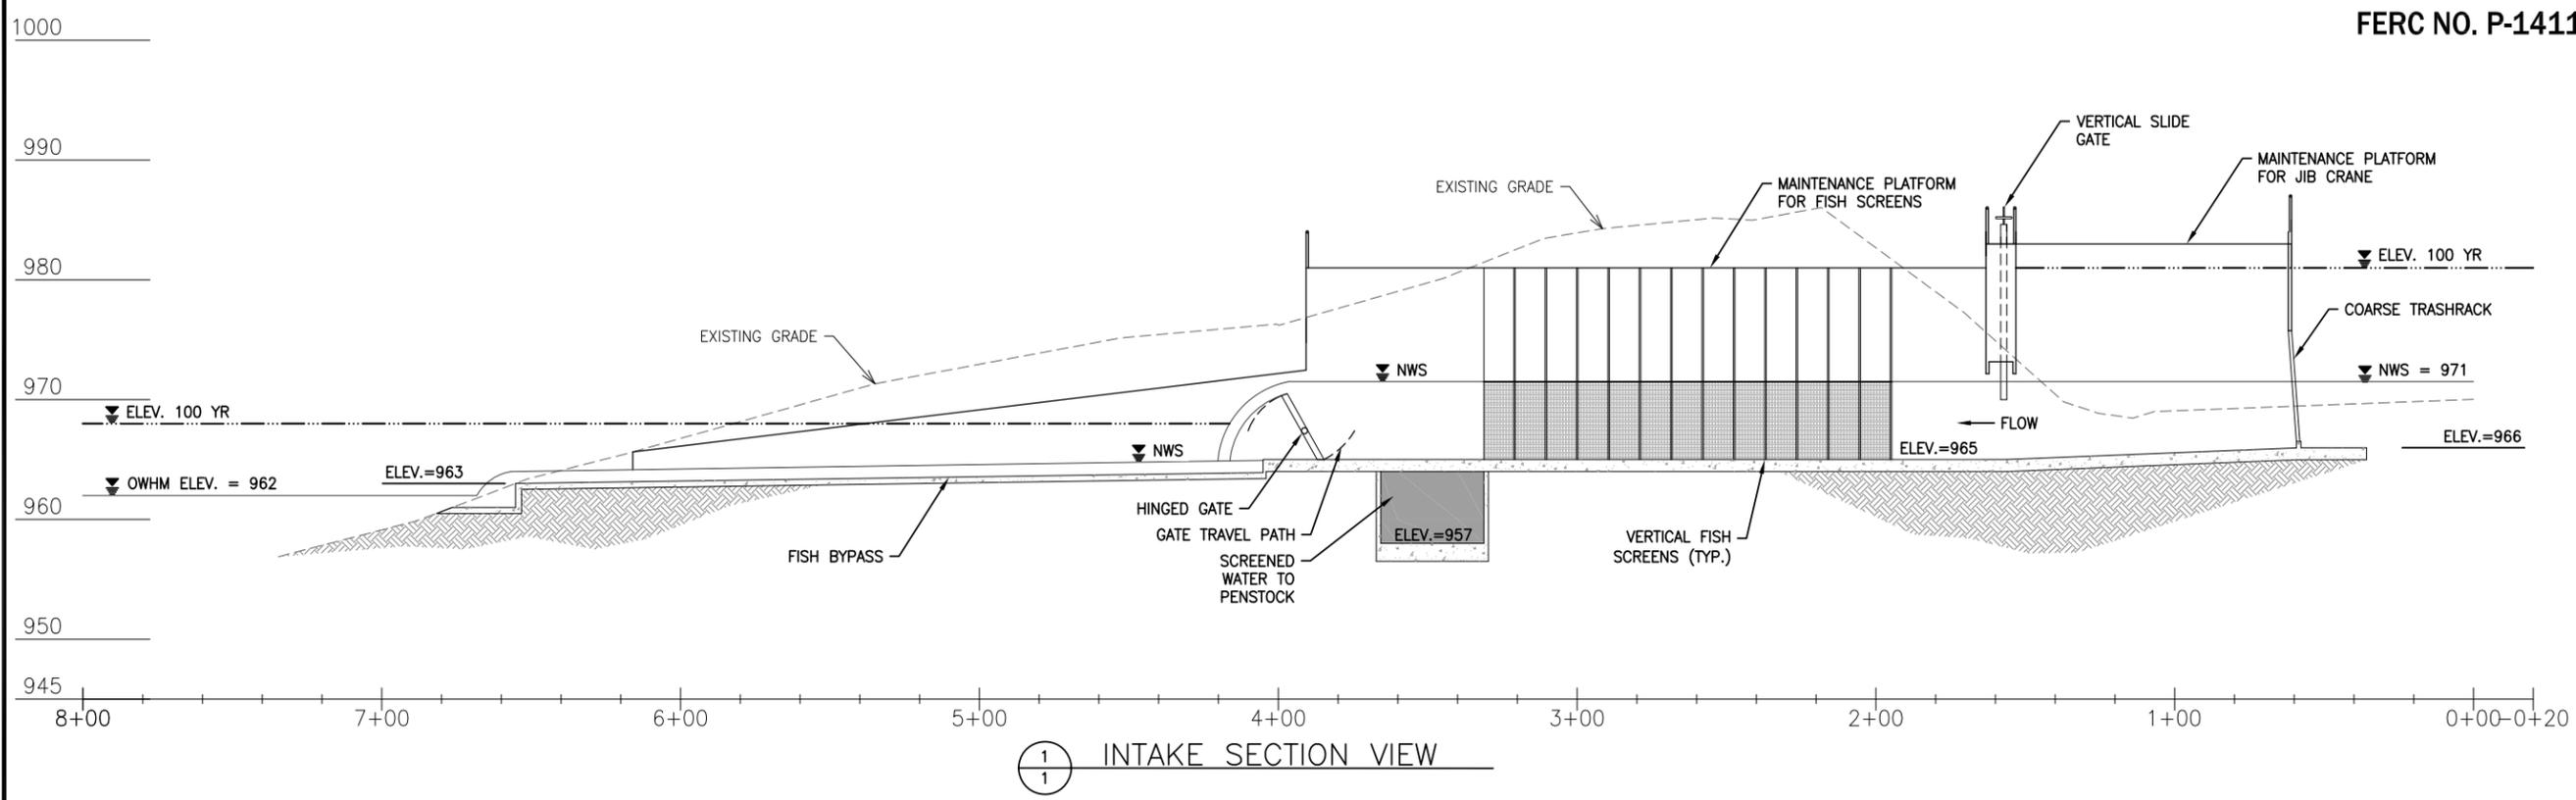
1 INTAKE SECTION VIEW

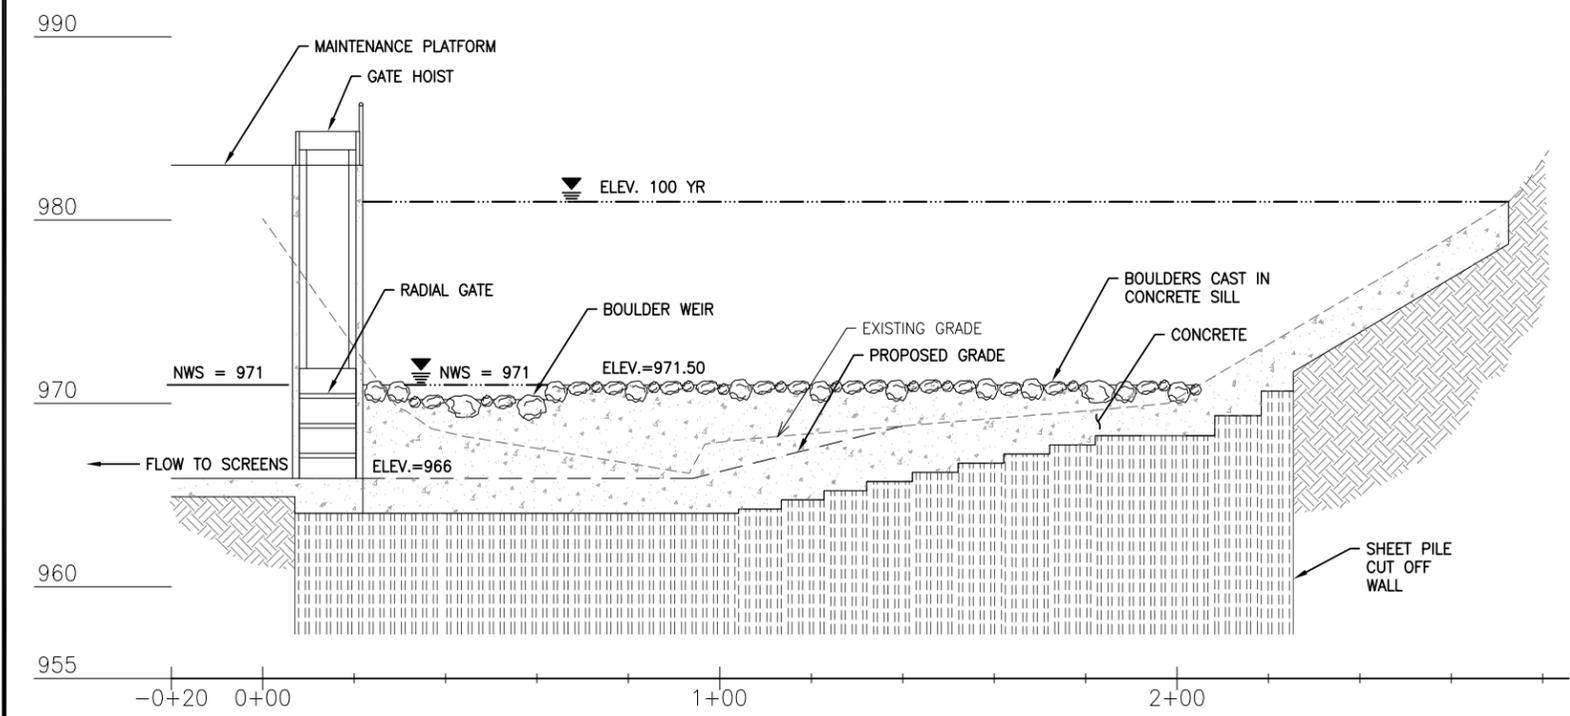
2 PROPOSED RIVER CROSS SECTION
