Black Canyon Hydroelectric Project
FERC Project No. P-14110
Fish Passage Report
February 2014

Prepared for
Black Canyon Hydro, LLC
3633 Alderwood Avenue
Bellingham, WA 98225

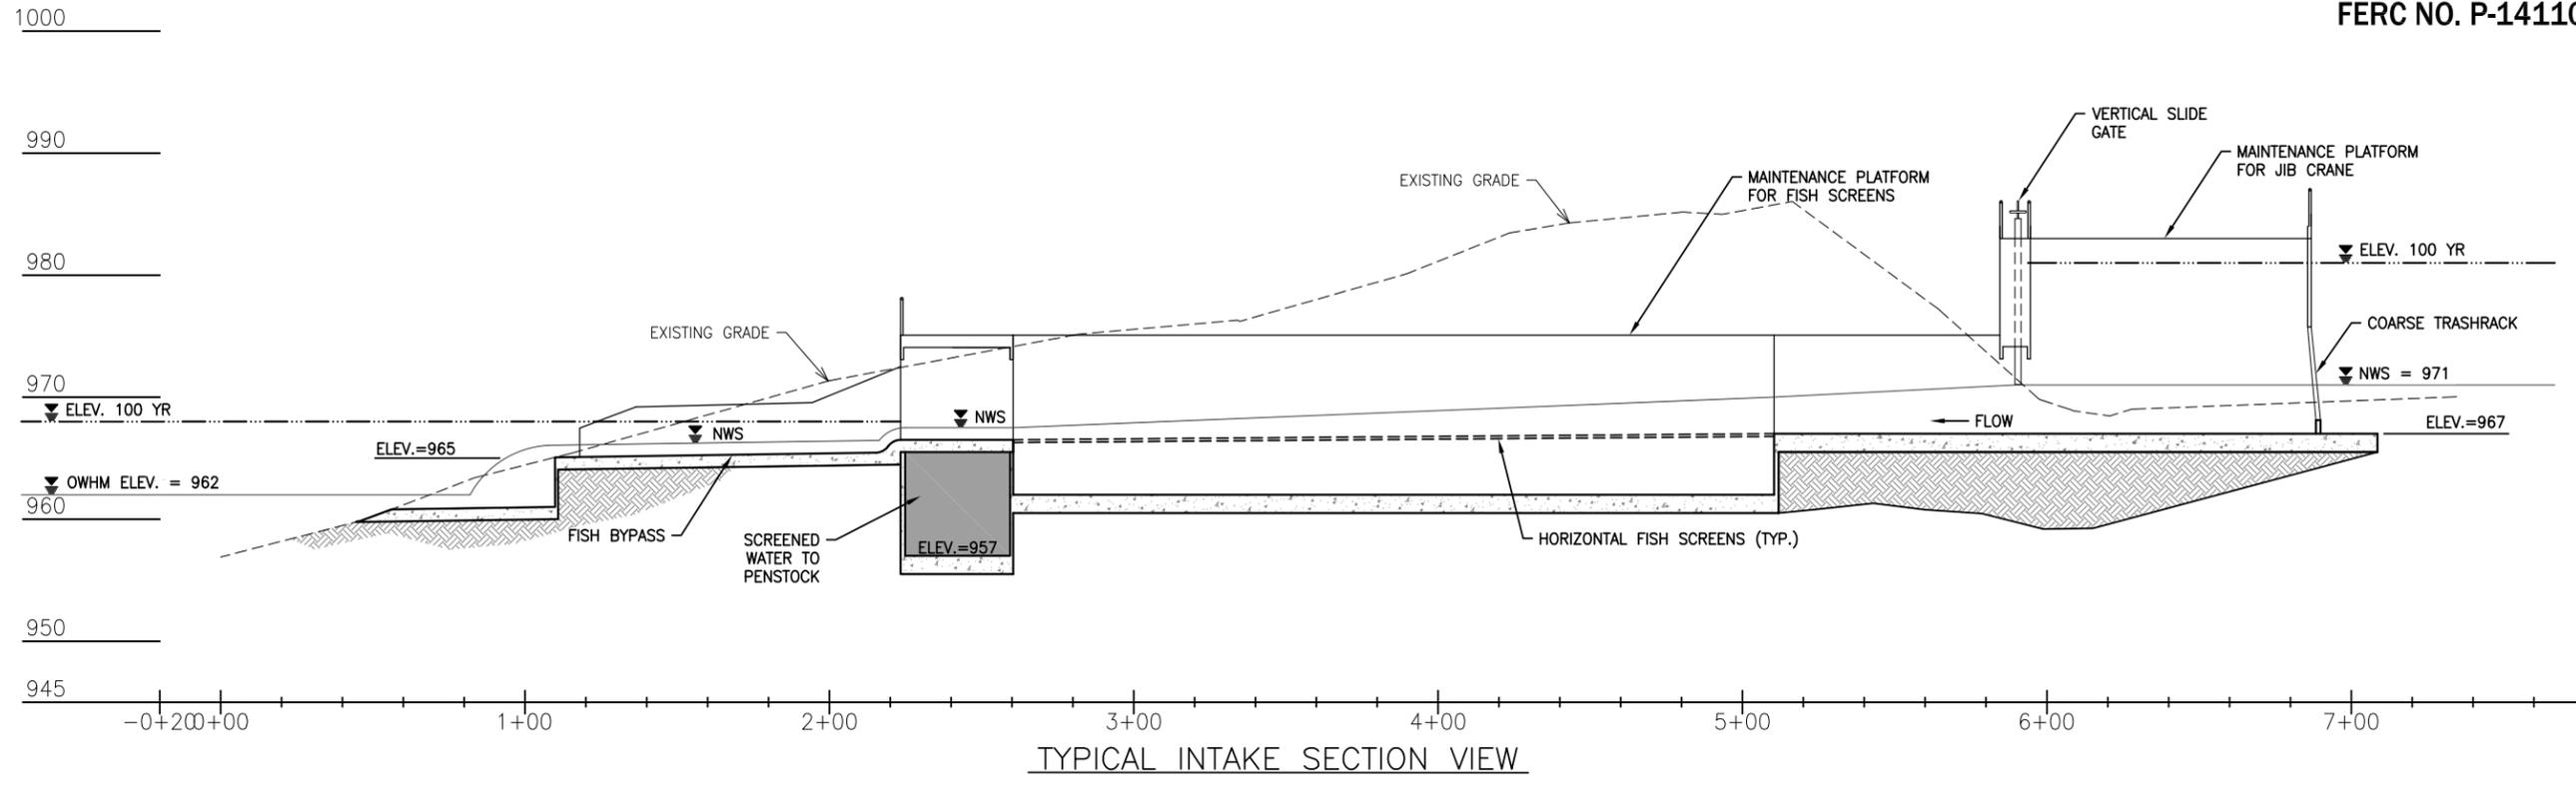
TYPICAL INTAKE SECTION VIEW

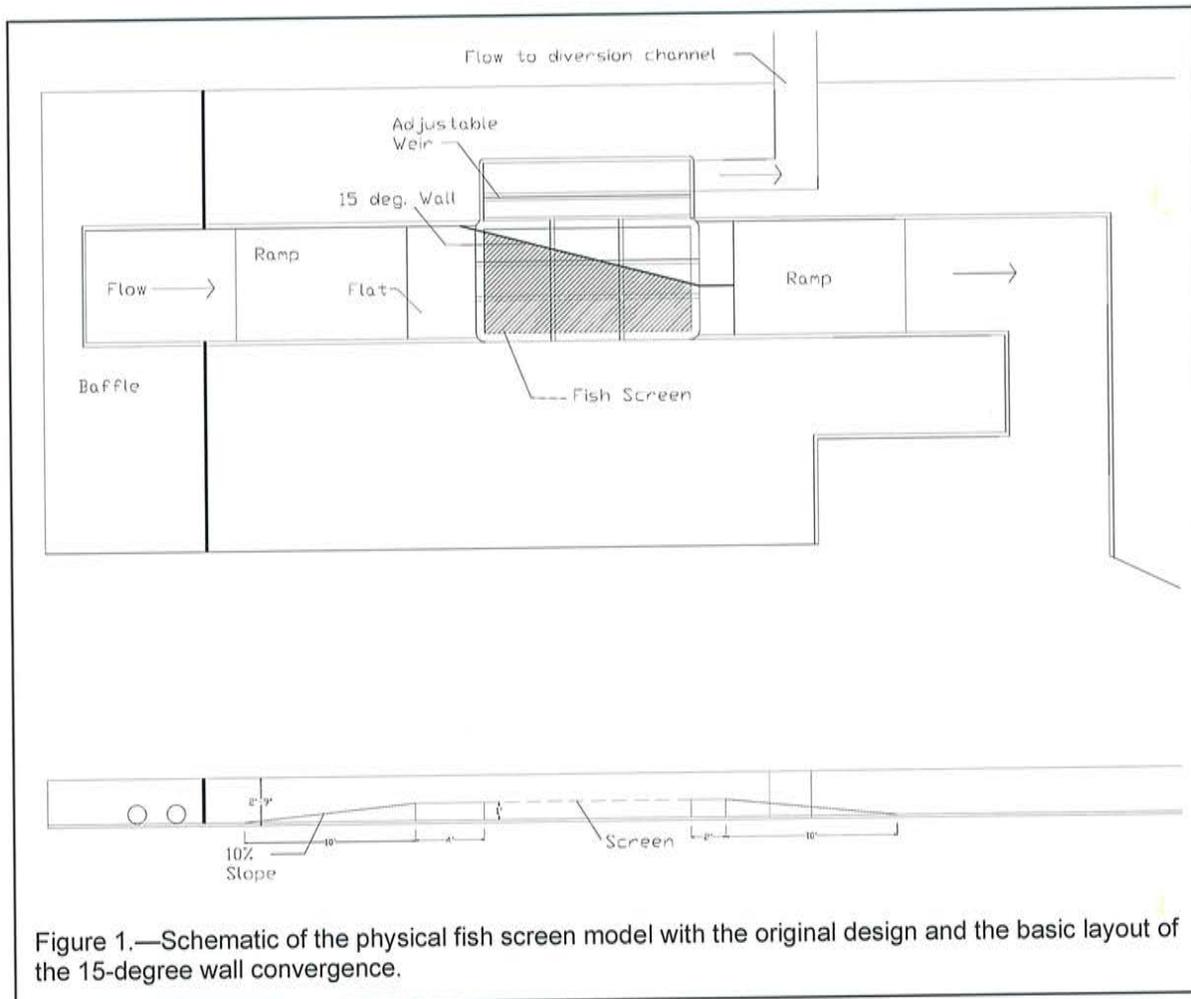
Figure 1.—Schematic of the physical fish screen model with the original design and the basic layout of the 15-degree wall convergence.

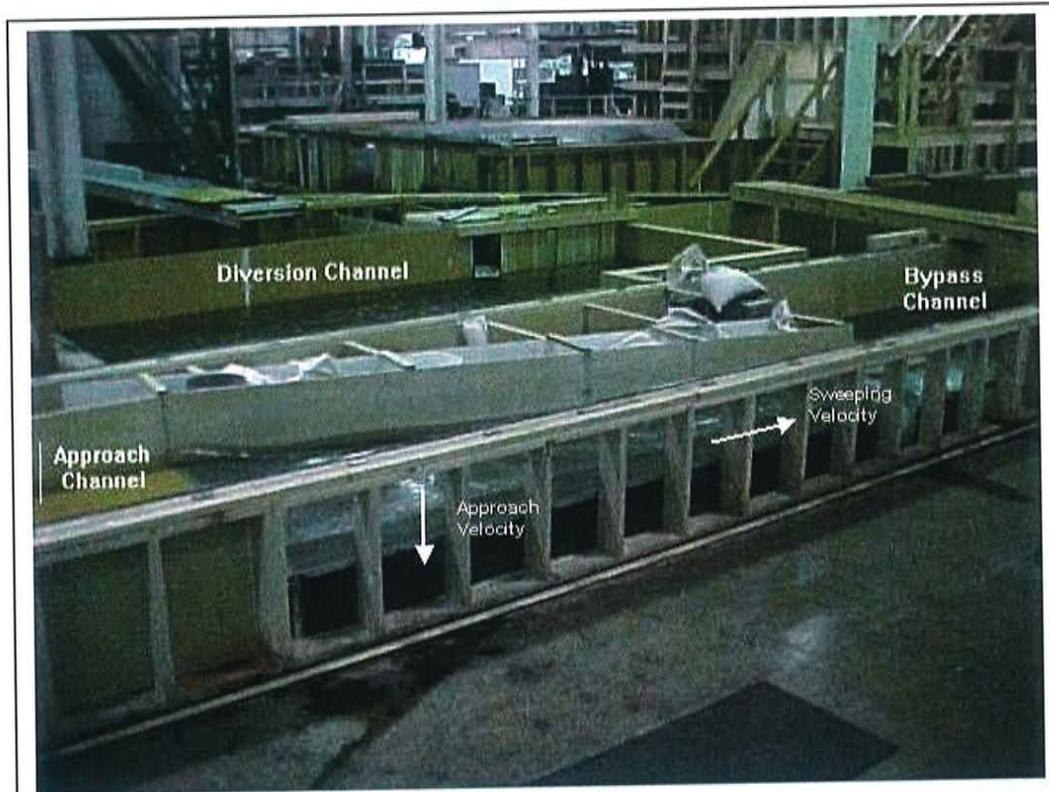
Figure 2.—Overall view of the horizontal screen model showing the flow channel designations and velocity orientations.

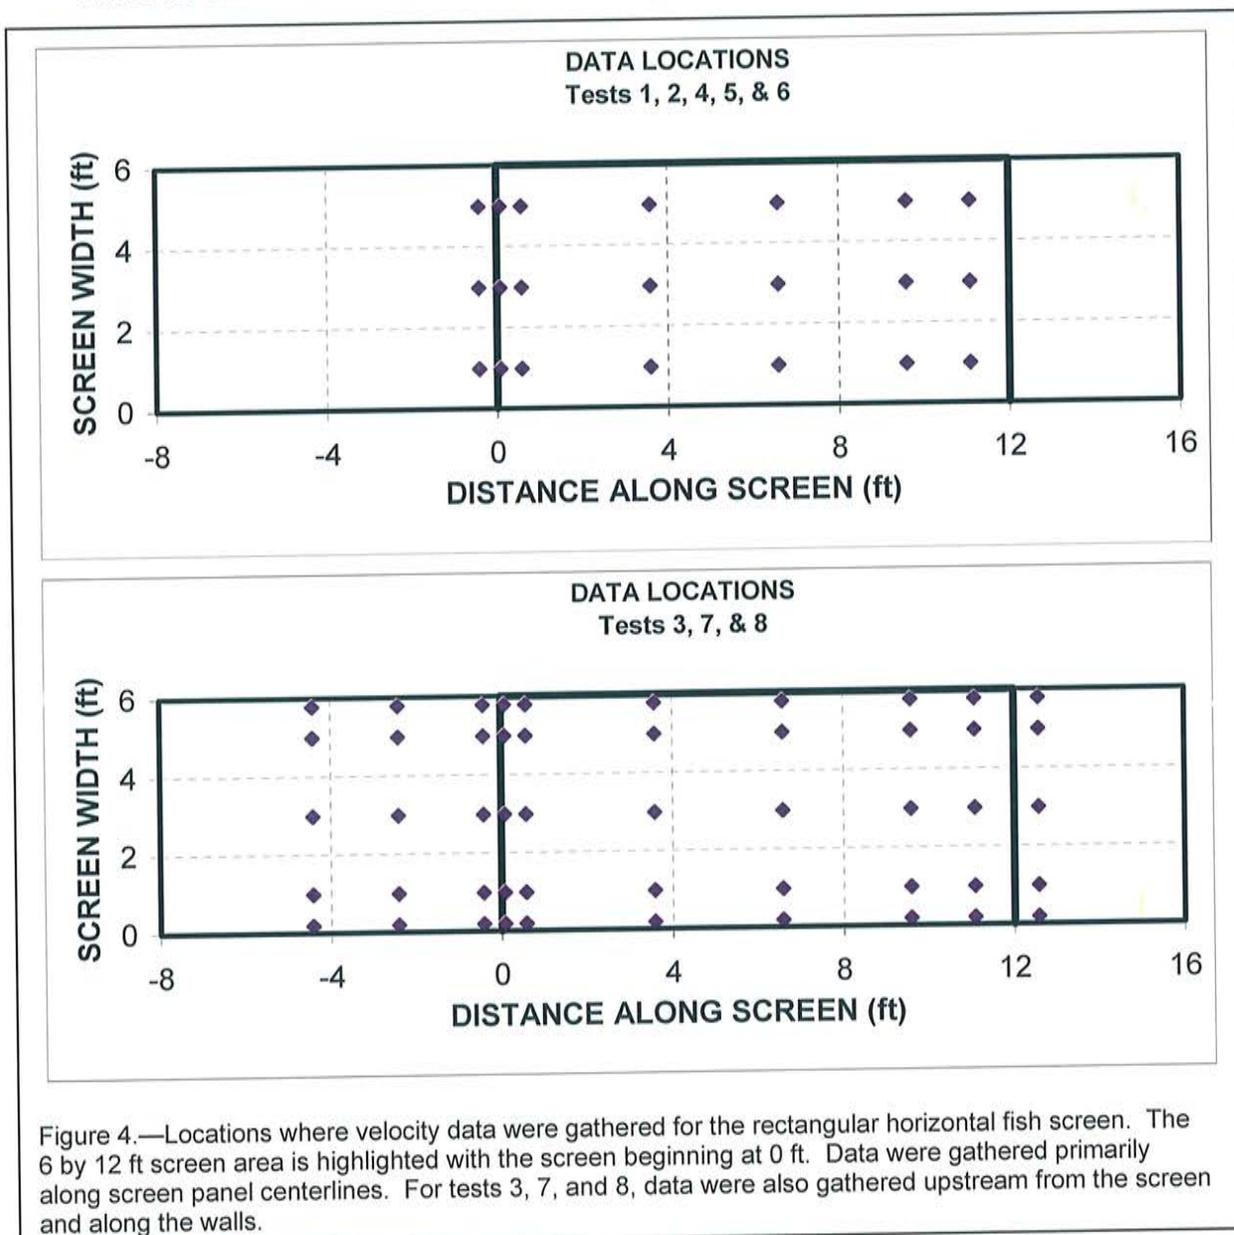
Figure 4.—Locations where velocity data were gathered for the rectangular horizontal fish screen. The 6 by 12 ft screen area is highlighted with the screen beginning at 0 ft. Data were gathered primarily along screen panel centerlines. For tests 3, 7, and 8, data were also gathered upstream from the screen and along the walls.

Data were collected 3 inches above the screen to correspond to the standard measurement distance in the prototype. Velocity measurements were obtained at grid points that were established for the screen geometry tested.

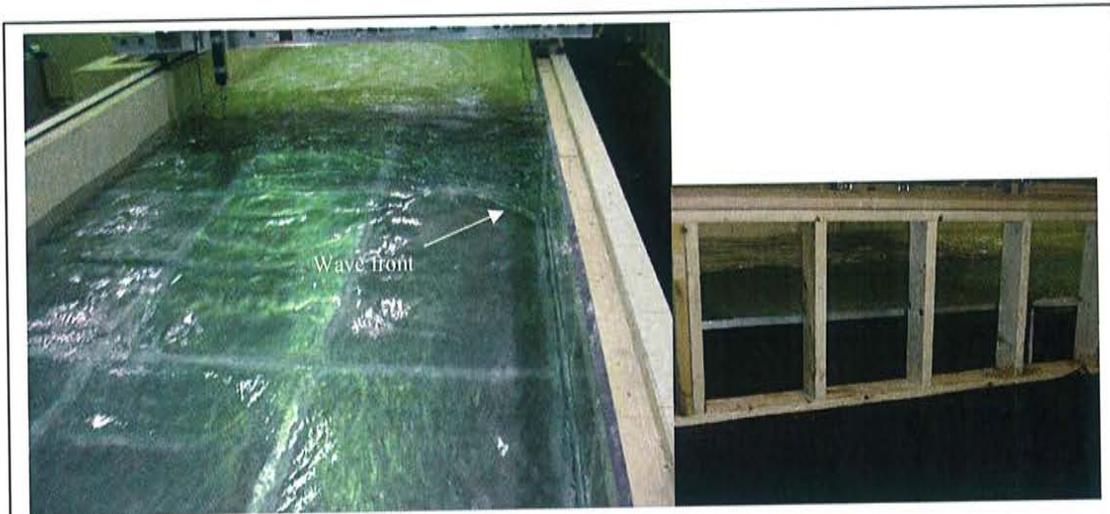
Figure 5.—Test 1 with the rectangular screen geometry, $Q_c = 10 \text{ ft}^3/\text{s}$, and $Q_d/Q_c = 0.83$ and downstream control of the bypass. The flow over the screen is subcritical and downstream control is causing a recirculation pattern over the downstream portion of the screen. The wavy, higher water surface indicates the location of the recirculation. The velocity of approach increases above 0.2 ft/s in this area because of the ponded flow. This would be an unacceptable flow condition.

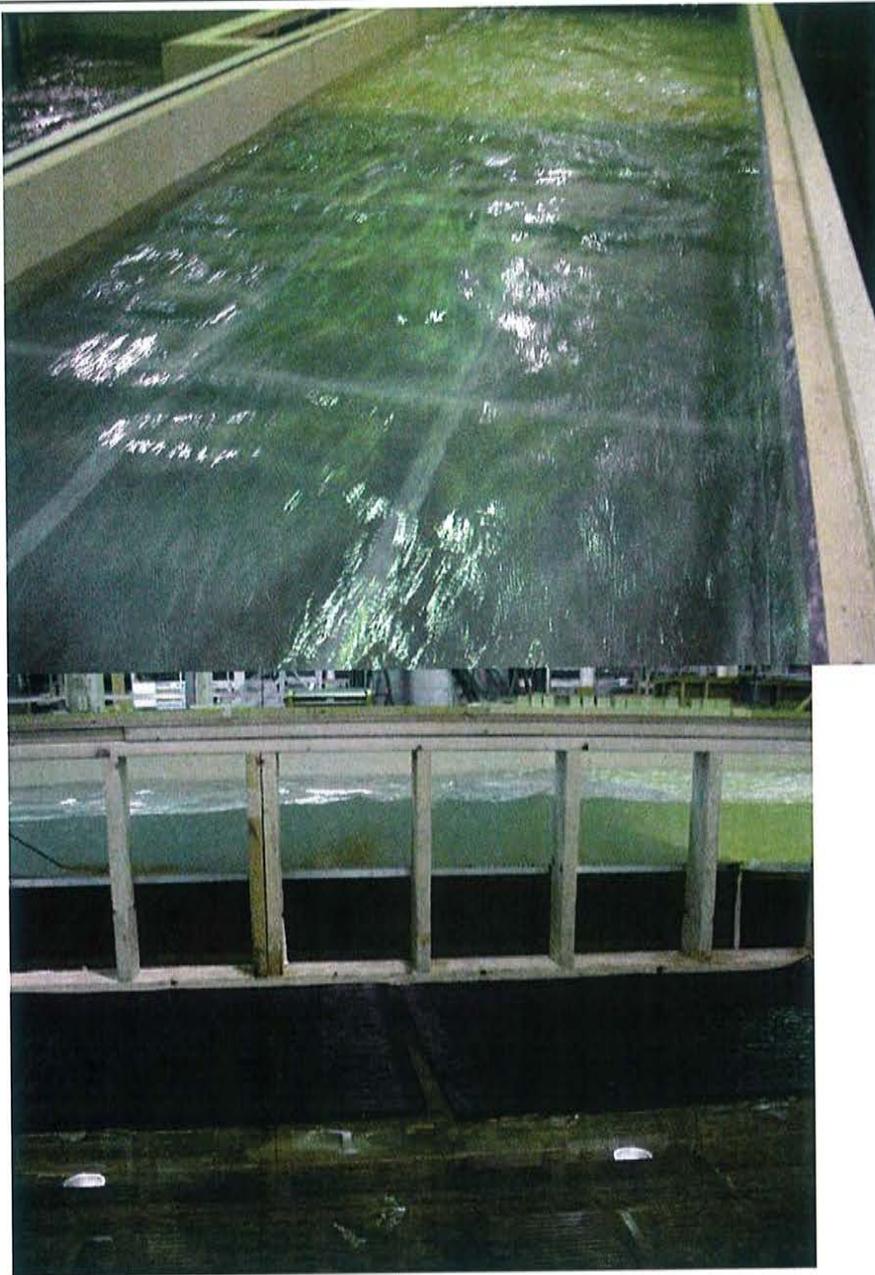
Figure 6.—Test 2 looking down onto the downstream end of the rectangular screen. Subcritical flow over the screen with $Q_d/Q_c=0.70$ and $V_a=0.115$ ft/s. The upstream $V_s/V_a=34:1$, and the downstream $V_s/V_a=10:1$ with the channel discharge, depth, and screen width used to compute the sweeping velocity. Compare to test 1 and test 3 with same approach velocity, depth and $V_s/V_a=5$ and 20 to 1.

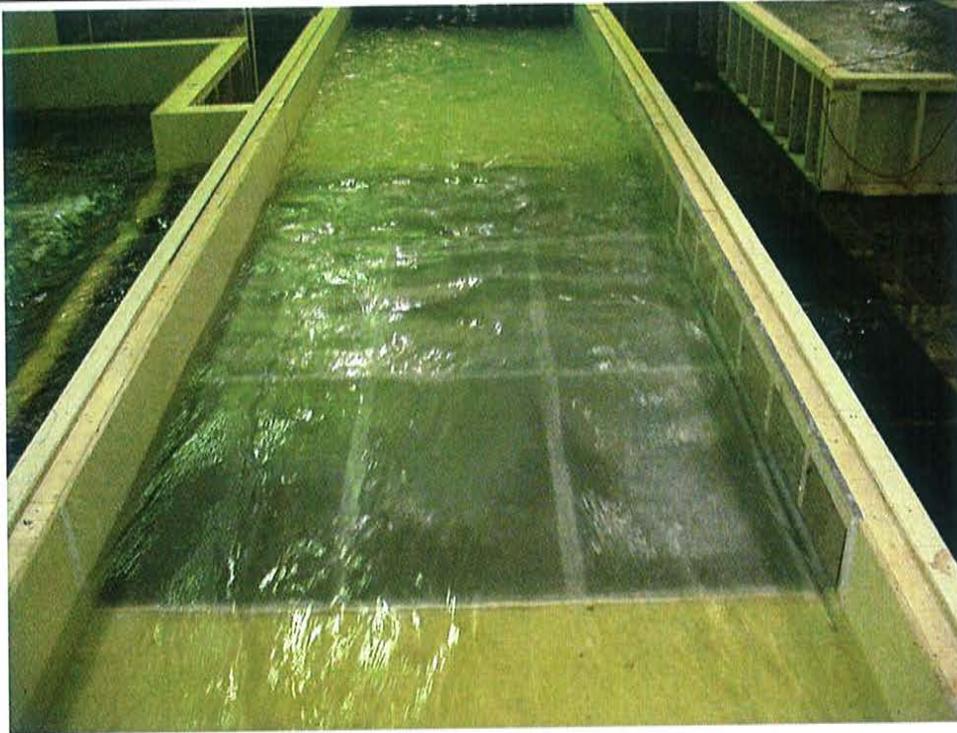
Figure 7.—Top and side views of test 3 with supercritical flow at the upstream end of the screen transitioning to subcritical with a jump over the downstream end of the screen. $Q_d/Q_c=0.55$ and $V_a=0.115$ ft/s. The upstream $V_s/V_a=44:1$, and the downstream $V_s/V_a=20:1$, with the channel discharge, depth, and screen width used to compute the sweeping velocity. Compare to test 1 and test 2 with same approach velocity, depth, and $V_s/V_a=5$ and 10 to 1 .

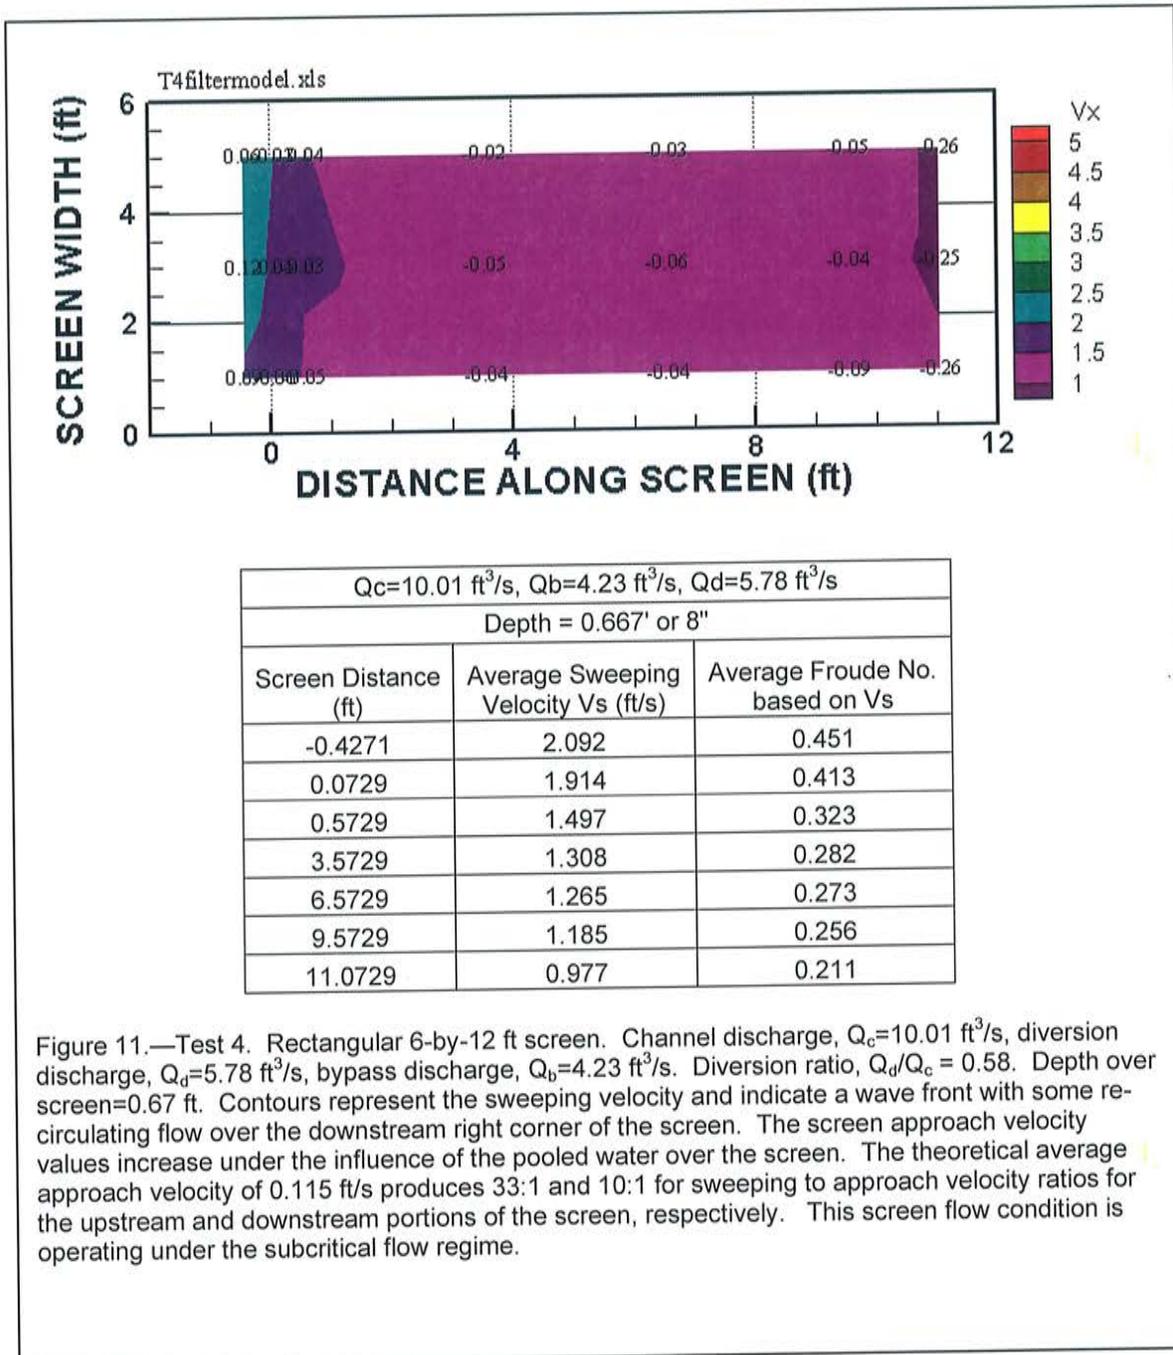
Figure 11.—Test 4. Rectangular 6-by-12 ft screen. Channel discharge, $Q_c=10.01 \text{ ft}^3/\text{s}$, diversion discharge, $Q_d=5.78 \text{ ft}^3/\text{s}$, bypass discharge, $Q_b=4.23 \text{ ft}^3/\text{s}$. Diversion ratio, $Q_d/Q_c = 0.58$. Depth over screen=0.67 ft. Contours represent the sweeping velocity and indicate a wave front with some recirculating flow over the downstream right corner of the screen. The screen approach velocity values increase under the influence of the pooled water over the screen. The theoretical average approach velocity of 0.115 ft/s produces 33:1 and 10:1 for sweeping to approach velocity ratios for the upstream and downstream portions of the screen, respectively. This screen flow condition is operating under the subcritical flow regime.

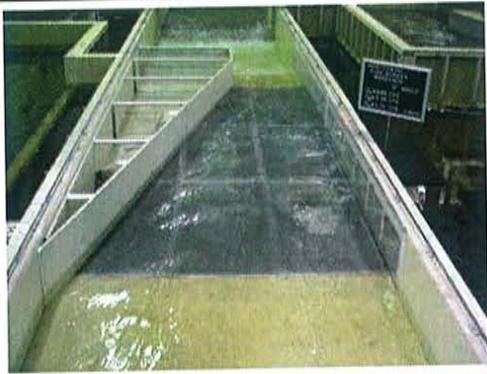
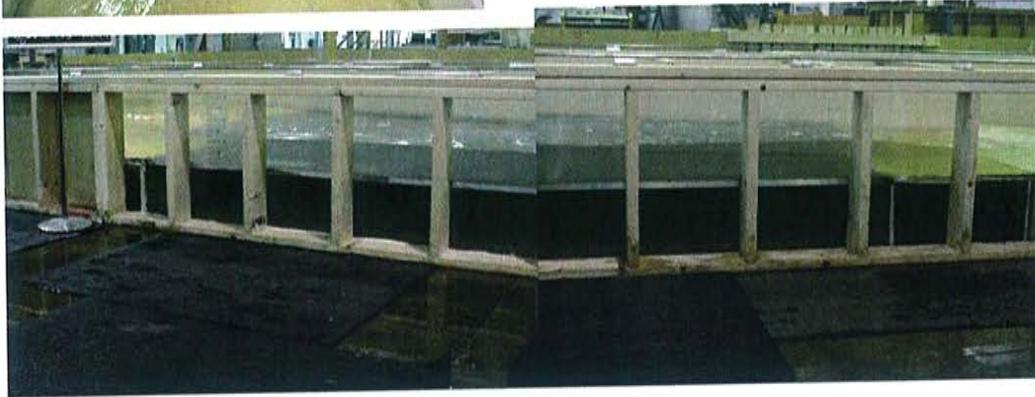
Figure 17.—Test 10. Converging side wall test with $Q_c = 6.92 \text{ ft}^3/\text{s}$, $Q_d/Q_c = 0.58$ and no influence on the screen from downstream control. Flow is subcritical throughout and sweeping velocities are constant from upstream to downstream. This screen geometry and flow condition was used for the bull trout testing under a sweeping velocity of 2 ft/s .

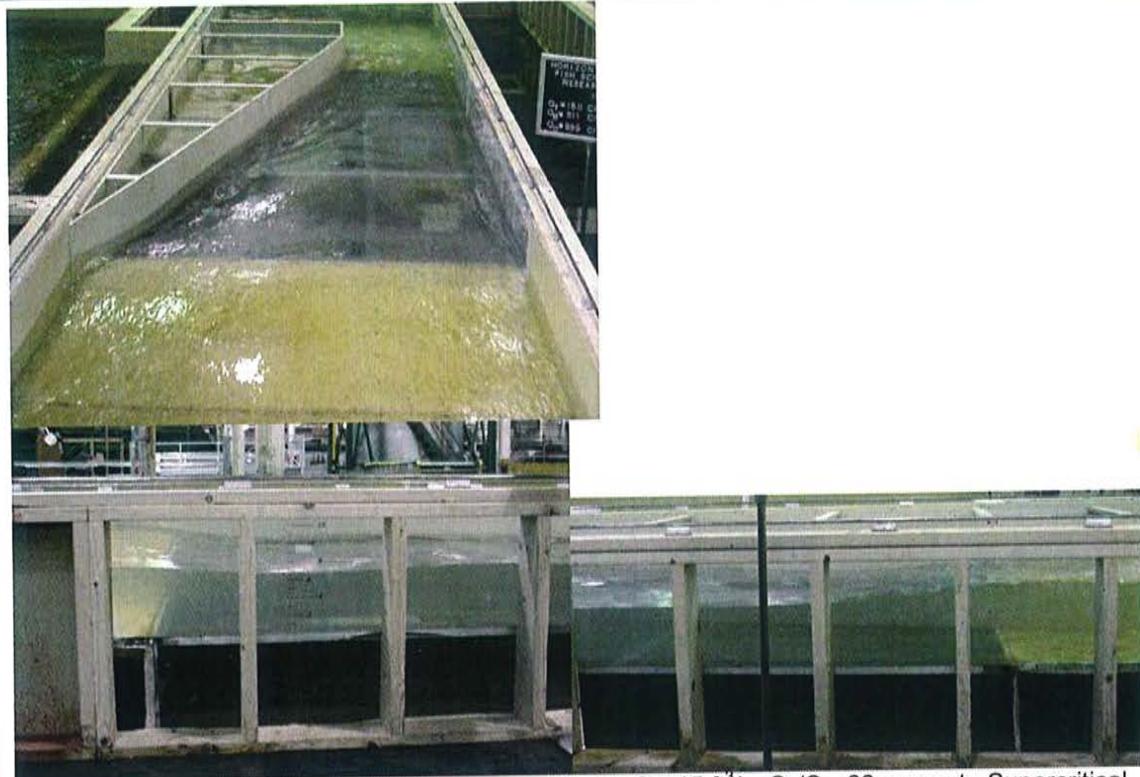
Figure 18.—Test 13. Test of converging side wall with $Q_c=15 \text{ ft}^3/\text{s}$, $Q_d/Q_c=66$ percent. Supercritical flow at the upstream end of the screen transitioning to subcritical about 7 ft onto the screen.

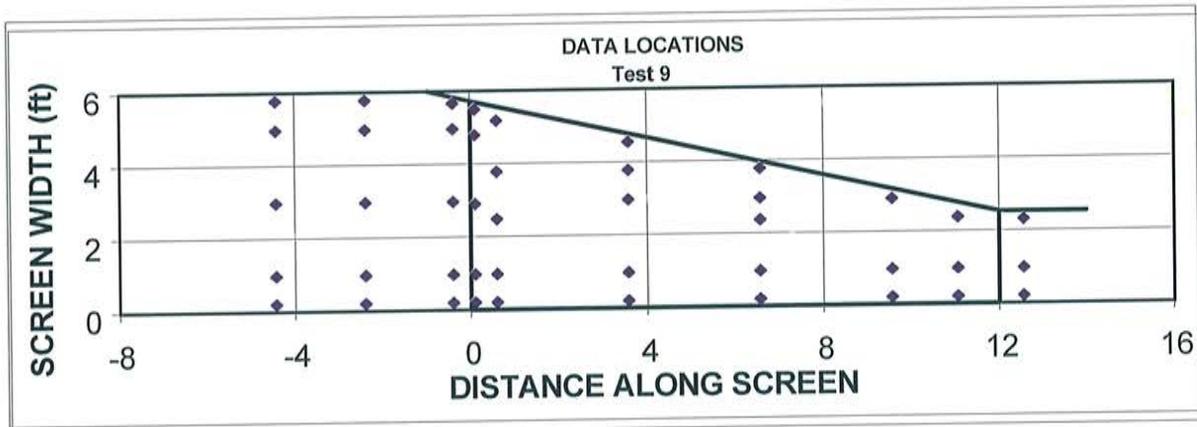
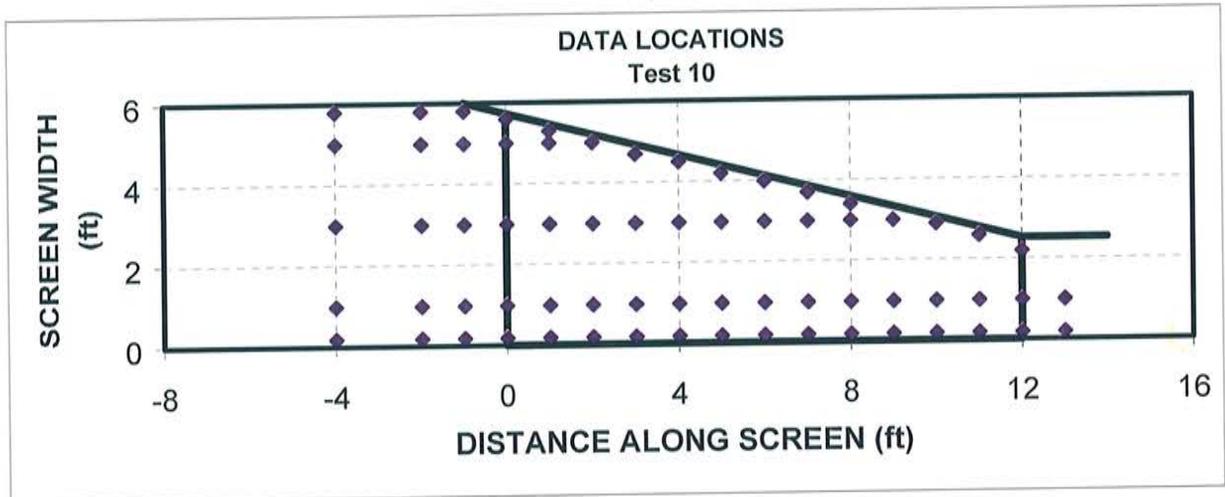
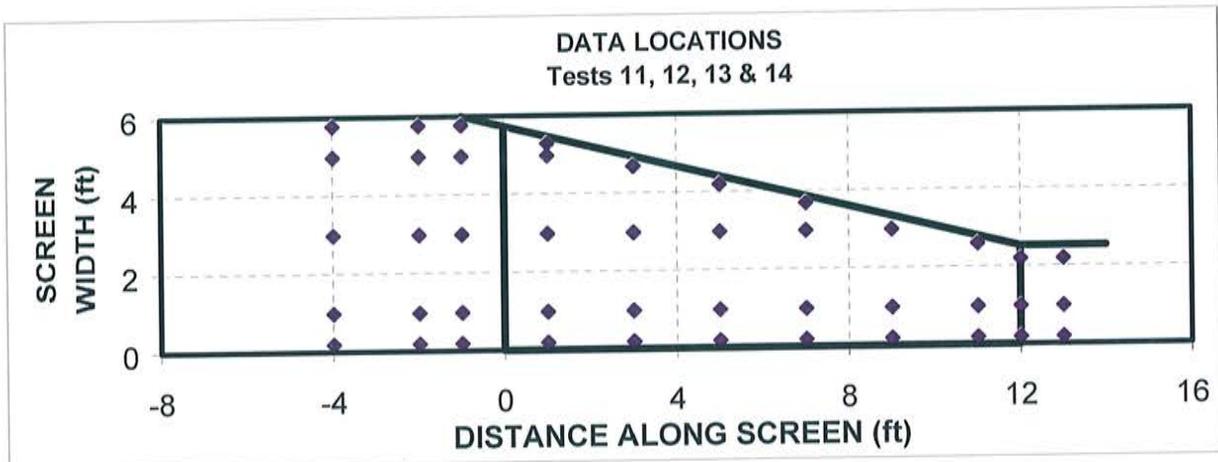
Figure 19.—Locations where velocity data were gathered for the 15° converging wall on the full-width horizontal fish screen. The exposed screen area is highlighted with the screen beginning at 0 ft. Data were gathered at various distances down the screen length primarily along screen panel centerlines and along the walls, including upstream and downstream from the screen. Test 15 data were only gathered along the screen length 1 ft from the right wall, looking downstream.

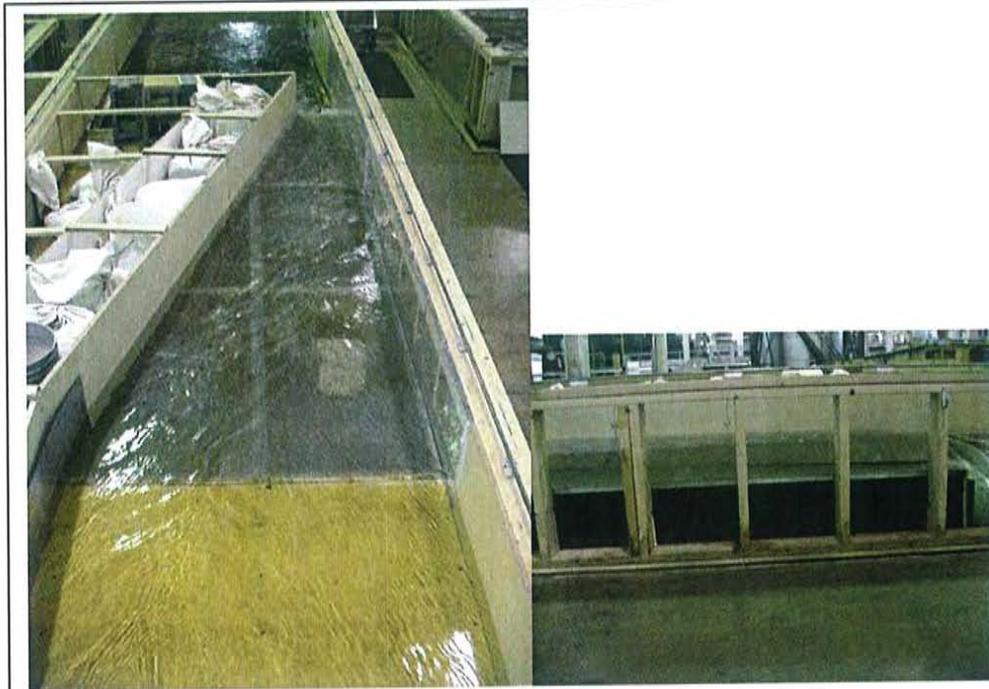
Figure 27.—Test 20. Critical flow at the downstream end of the screen with $Q_c = 4.07 \text{ ft}^3/\text{s}$ and $Q_d/Q_c = 67$ percent. Flow depth of 0.5 ft. The sweeping velocity is increasing across the screen and particularly as the flow enters the bypass opening. The approach velocity in the last foot of the screen is positive indicating that flow is coming up through the screen.

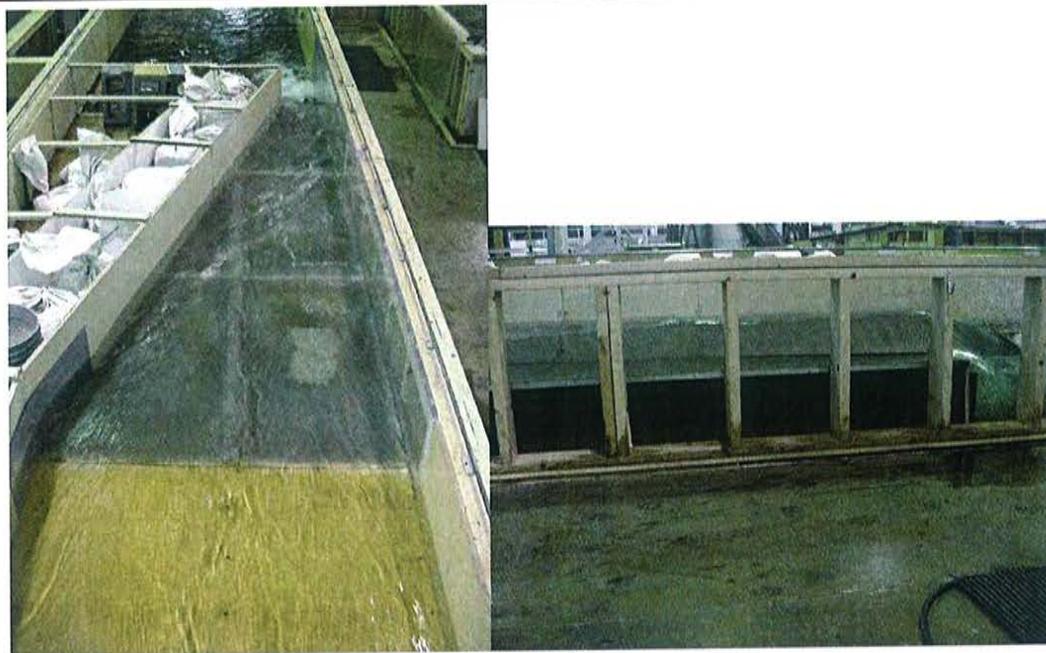
Figure 28.—Test 18. Critical flow at the downstream end of the screen with $Q_c = 9 \text{ ft}^3/\text{s}$ and $Q_d/Q_c = 74$ percent. Flow depth of 0.5 ft. The sweeping velocity is maintained across the screen and as the flow enters the bypass opening. The approach velocity over the last 2 feet of the screen exceeds the target of 0.2 ft/s indicating that the flow is deeper upstream from critical depth at the end of the screen. Notice the cross-waves extending the full width of the channel.

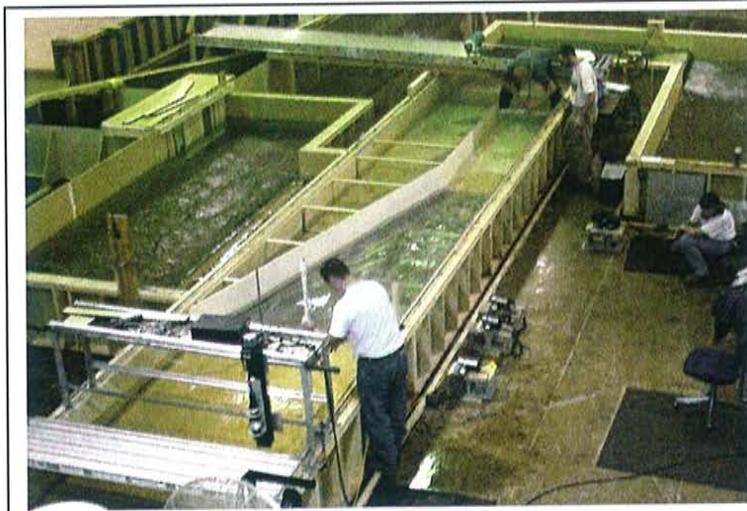
Figure 35.—Bull trout testing with the 15-degree converging wall over the screen.

Figures 35- 37 show the geometry and flow conditions under which the bull trout testing was performed.

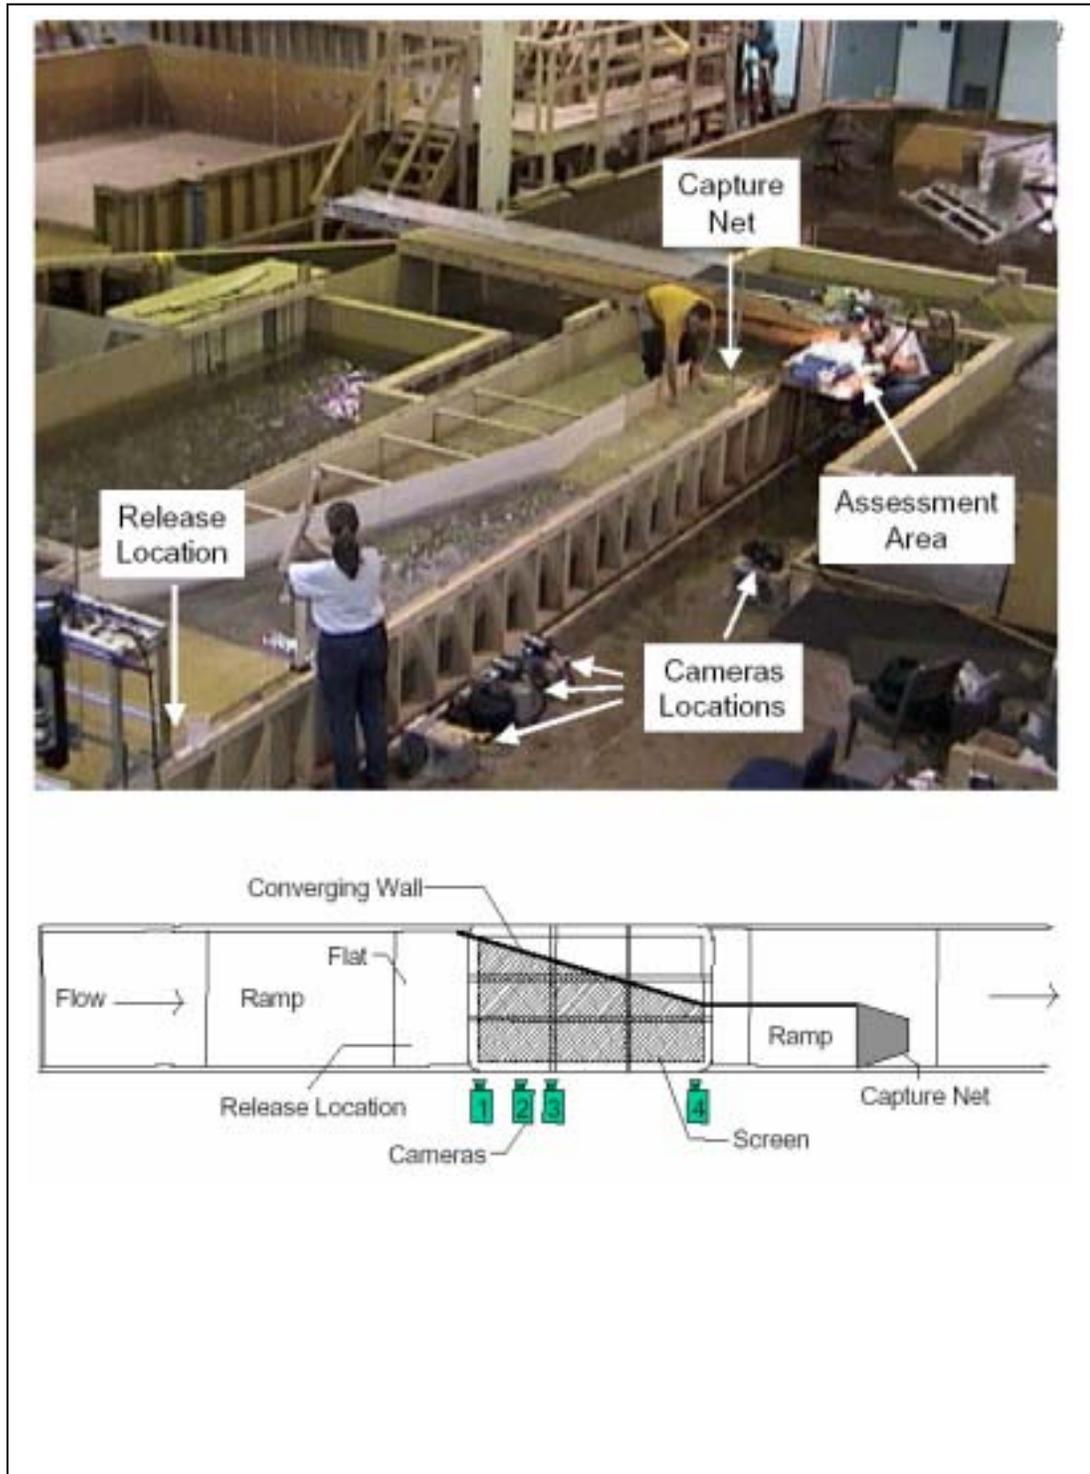
Figure 1. Picture and plan view of horizontal flat plate screen testing area.

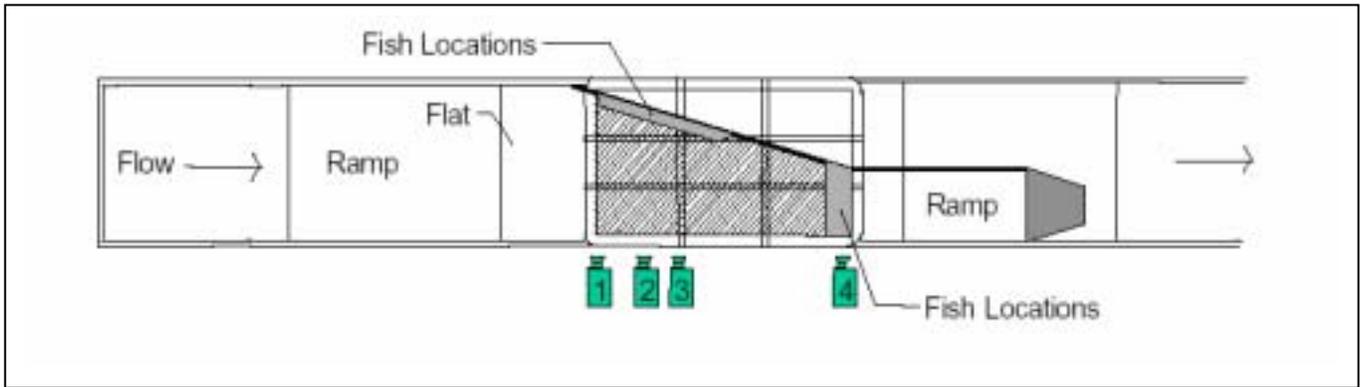
Figure 2. General areas (shaded) on a horizontal flat plate screen occupied by 58-mm bull trout for long periods of time. Downward pressure generated by the approach velocity of water passing through the screen in these areas allowed fish to hold position with relatively little swimming activity.

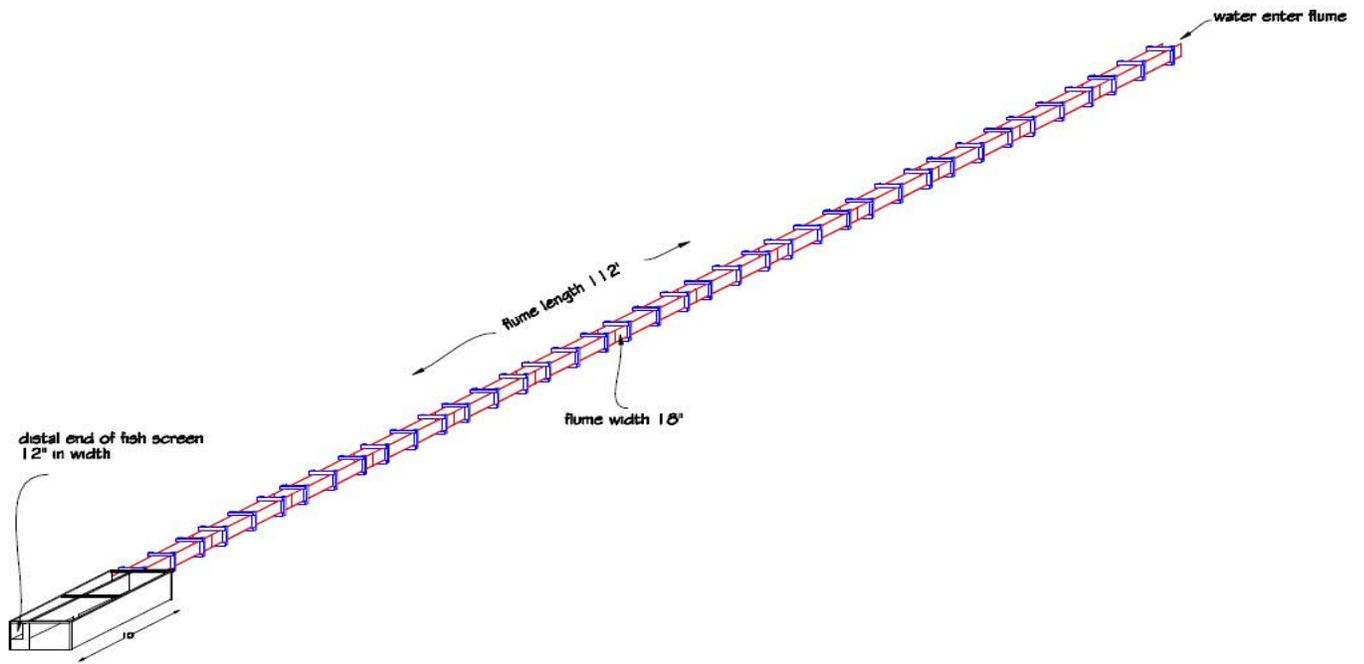
Figure 2. Schematic of the modular screen apparatus used to evaluate the behavioral responses of juvenile salmonids encountering the leading edge of the Farmers Screen, 2010. The modular screen apparatus consisted of a 34 m of wooden flume connected to a 3.1-m long section of the Farmers Screen.

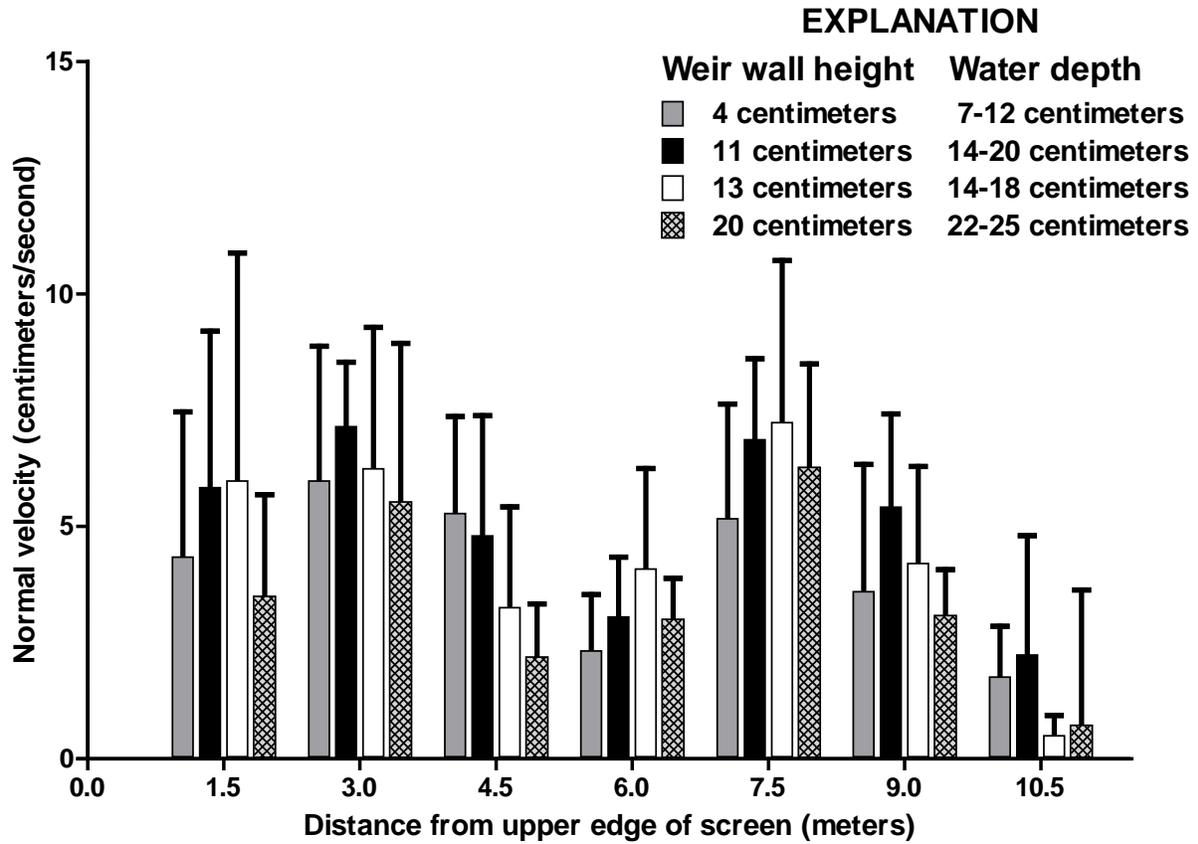
Figure 3. Mean normal velocities (approach velocities corrected for the net open area of the screen) estimated for different sections of the Herman Creek screen relative to weir wall height and water depth, 2009. The whiskers represent the standard deviations of the estimates.

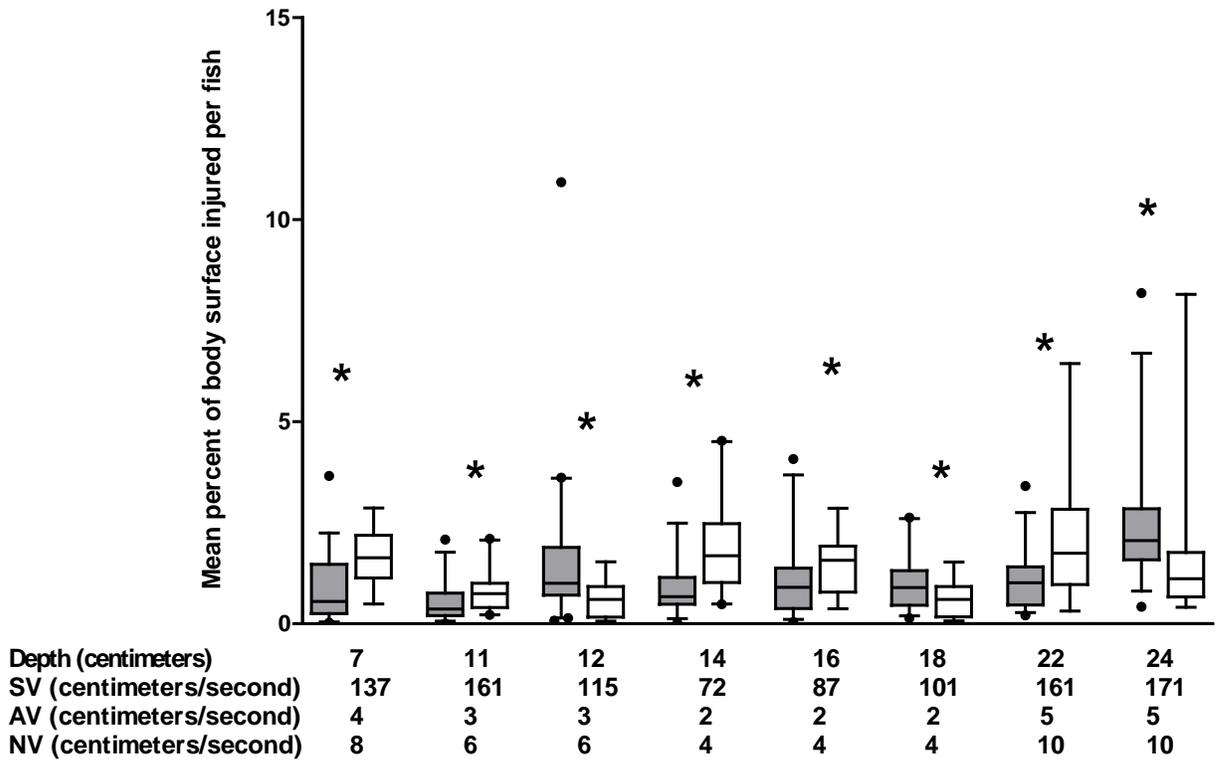
Figure 4. Distribution of the percentage of body surface area of large juvenile coho salmon injured when released over the Herman Creek screen (grey boxes) under various hydraulic conditions relative to control fish (white boxes). The upper and lower boundaries of the box represent the 25th and 75th quartiles, the line inside the box is the mean, the whiskers represent the 5- and 95-percent confidence intervals, and outliers are shown by solid points. The X-axis shows the water depth over the screen, the mean sweeping velocity (SV), the approach velocity (AV), and the normal velocity (NV) during each test. Asterisks denote a significant difference between medians within a group (Mann Whitney *U* test, $P < 0.05$).

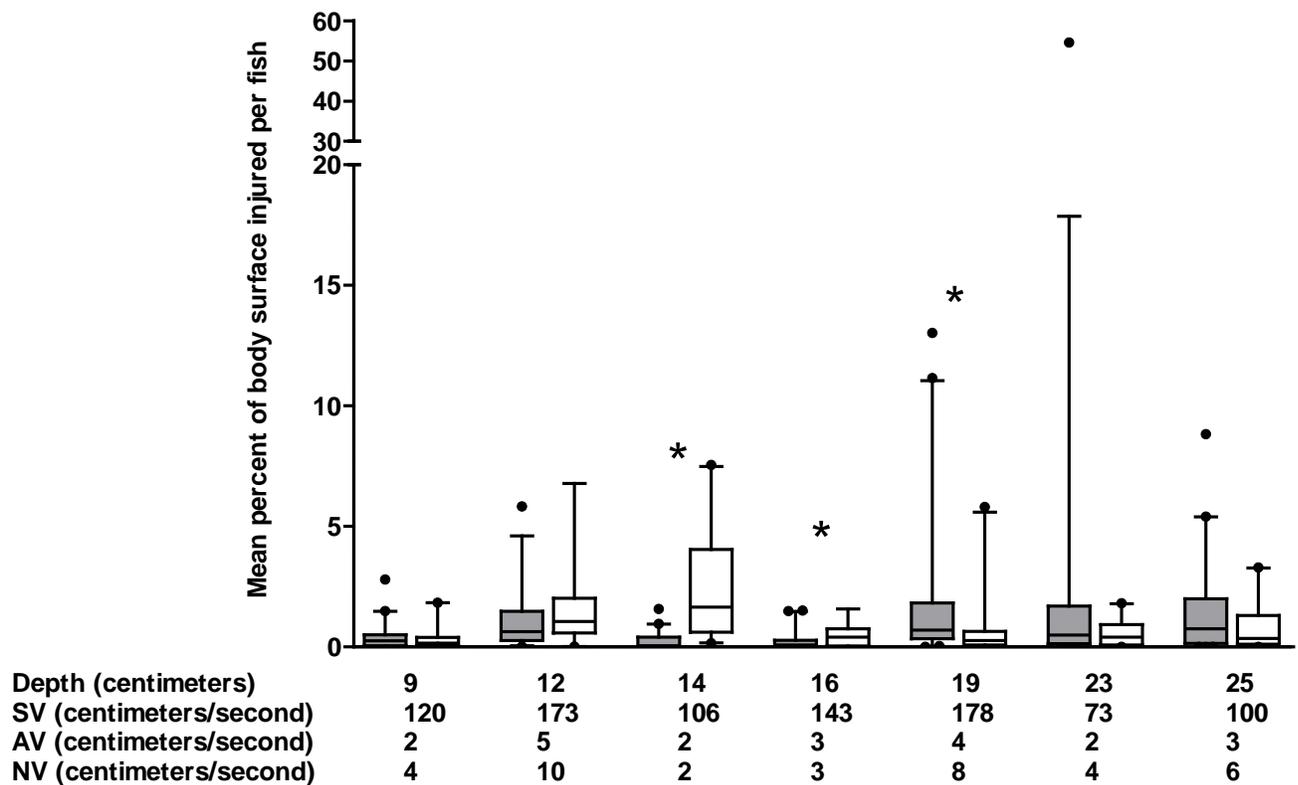
Figure 5. Distribution of the percentage of body surface area of small juvenile coho salmon injured when released over the Herman Creek screen (grey boxes) under different hydraulic conditions relative to control fish (white boxes). The upper and lower boundaries of the box represent the 25th and 75th quartiles, the line inside the box is the mean, the whiskers represent the 5- and 95-percent confidence intervals, and outliers are shown by solid points. The X-axis shows the water depth over the screen, the mean sweeping velocity (SV), the approach velocity (AV), and the normal velocity (NV) during each trial. Asterisks denote a significant difference between medians within a group (Mann Whitney *U* test, $P < 0.05$).
