Black Canyon Hydroelectric Project
FERC Project No. P-14110
Fish Passage Report
February 2014

Prepared for
Black Canyon Hydro, LLC
3633 Alderwood Avenue
Bellingham, WA 98225

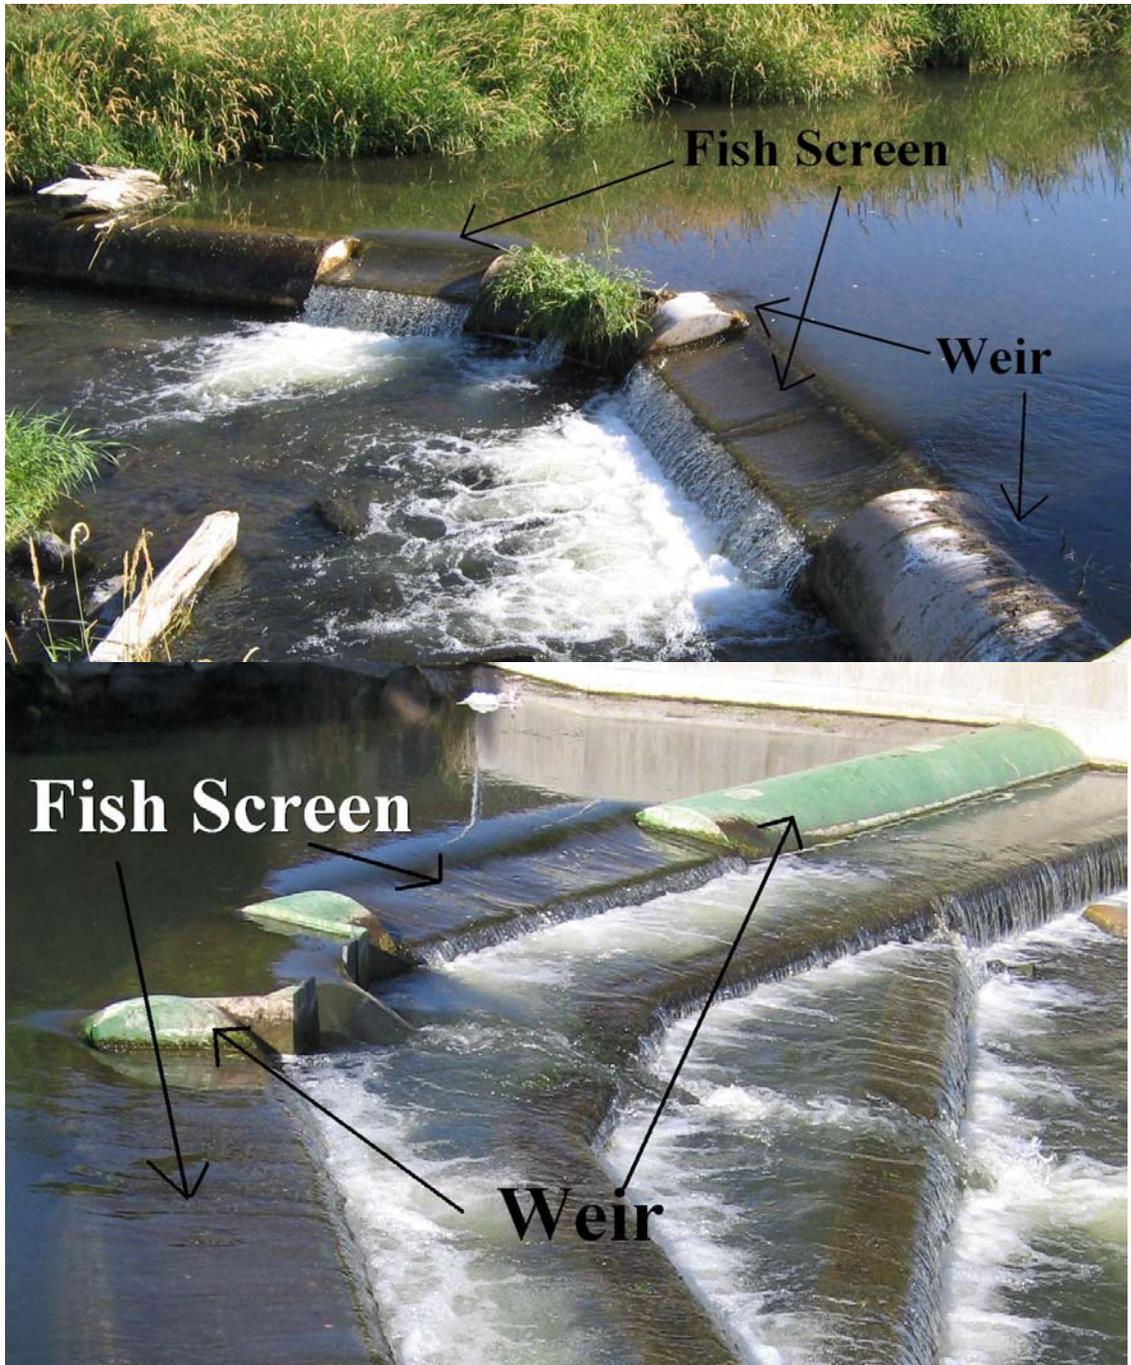
Figure 1. Photographs of the Smith (top) and Rye Grass (bottom) inverted weir flat plate fish screens located on Mckay and Ochoco Creeks near Prineville, Oregon. The screening panels are located in the cut-out areas of steel pipe. Note the V-notch passage structure in the middle of each screen.

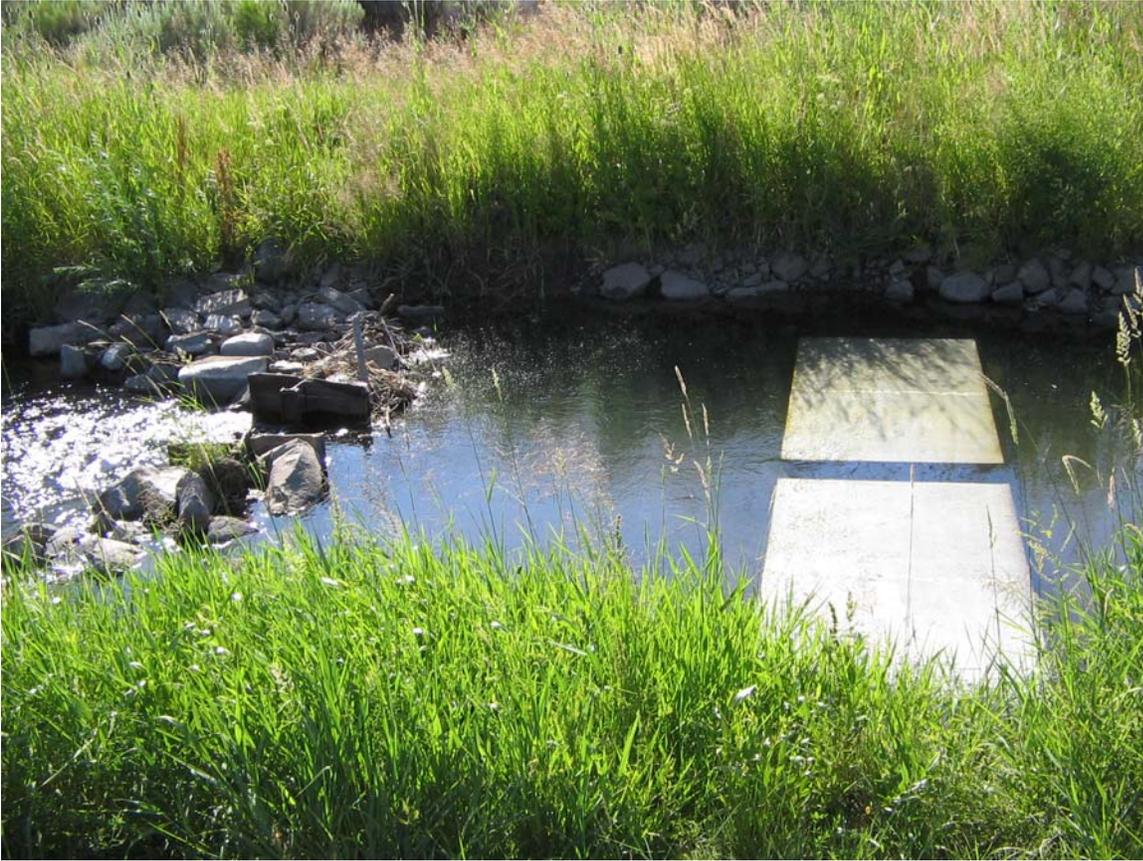
Figure 2. Photograph of the backwatered horizontal flat plate fish screen (the Malheur screen) and the rock weir flow control structure located in the East canal of the Donner und Blitzen River, Oregon

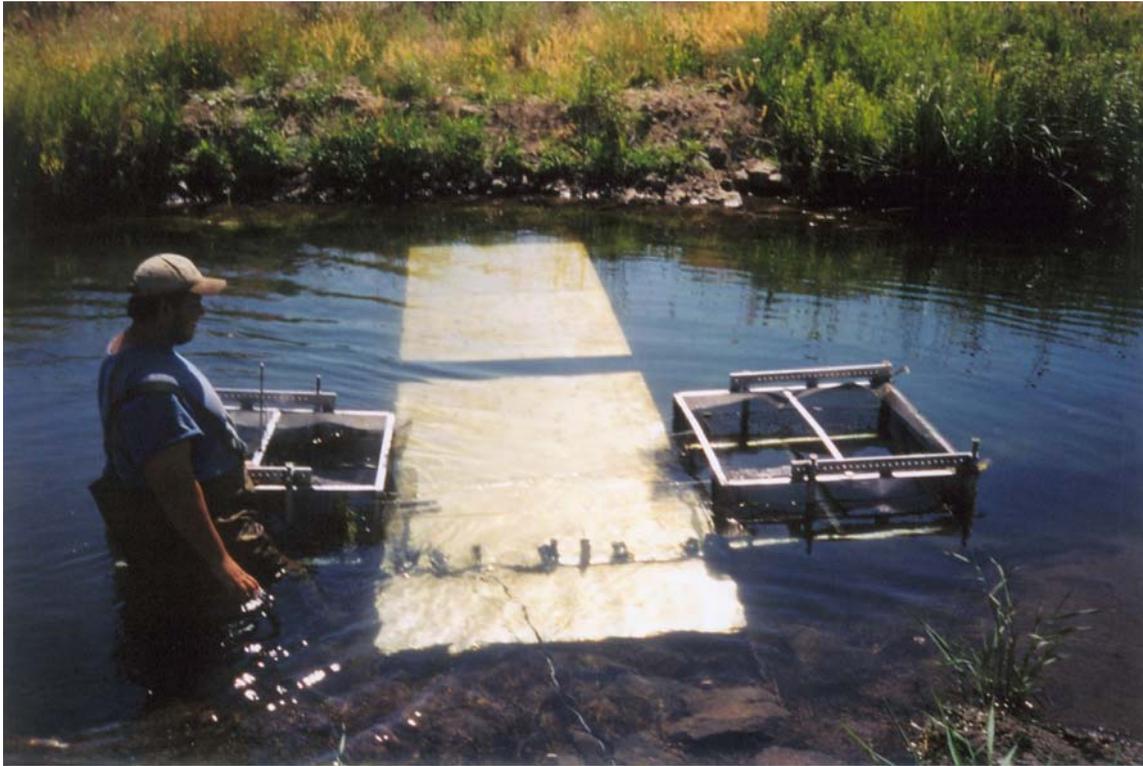
Figure 3. Apparatus used to experimentally release juvenile rainbow trout over selected horizontal flat plate screens in the field. The device is shown here attached to the Malheur screen. Each site required modifications to account for differences in water turbidity and structural variations of the screens.

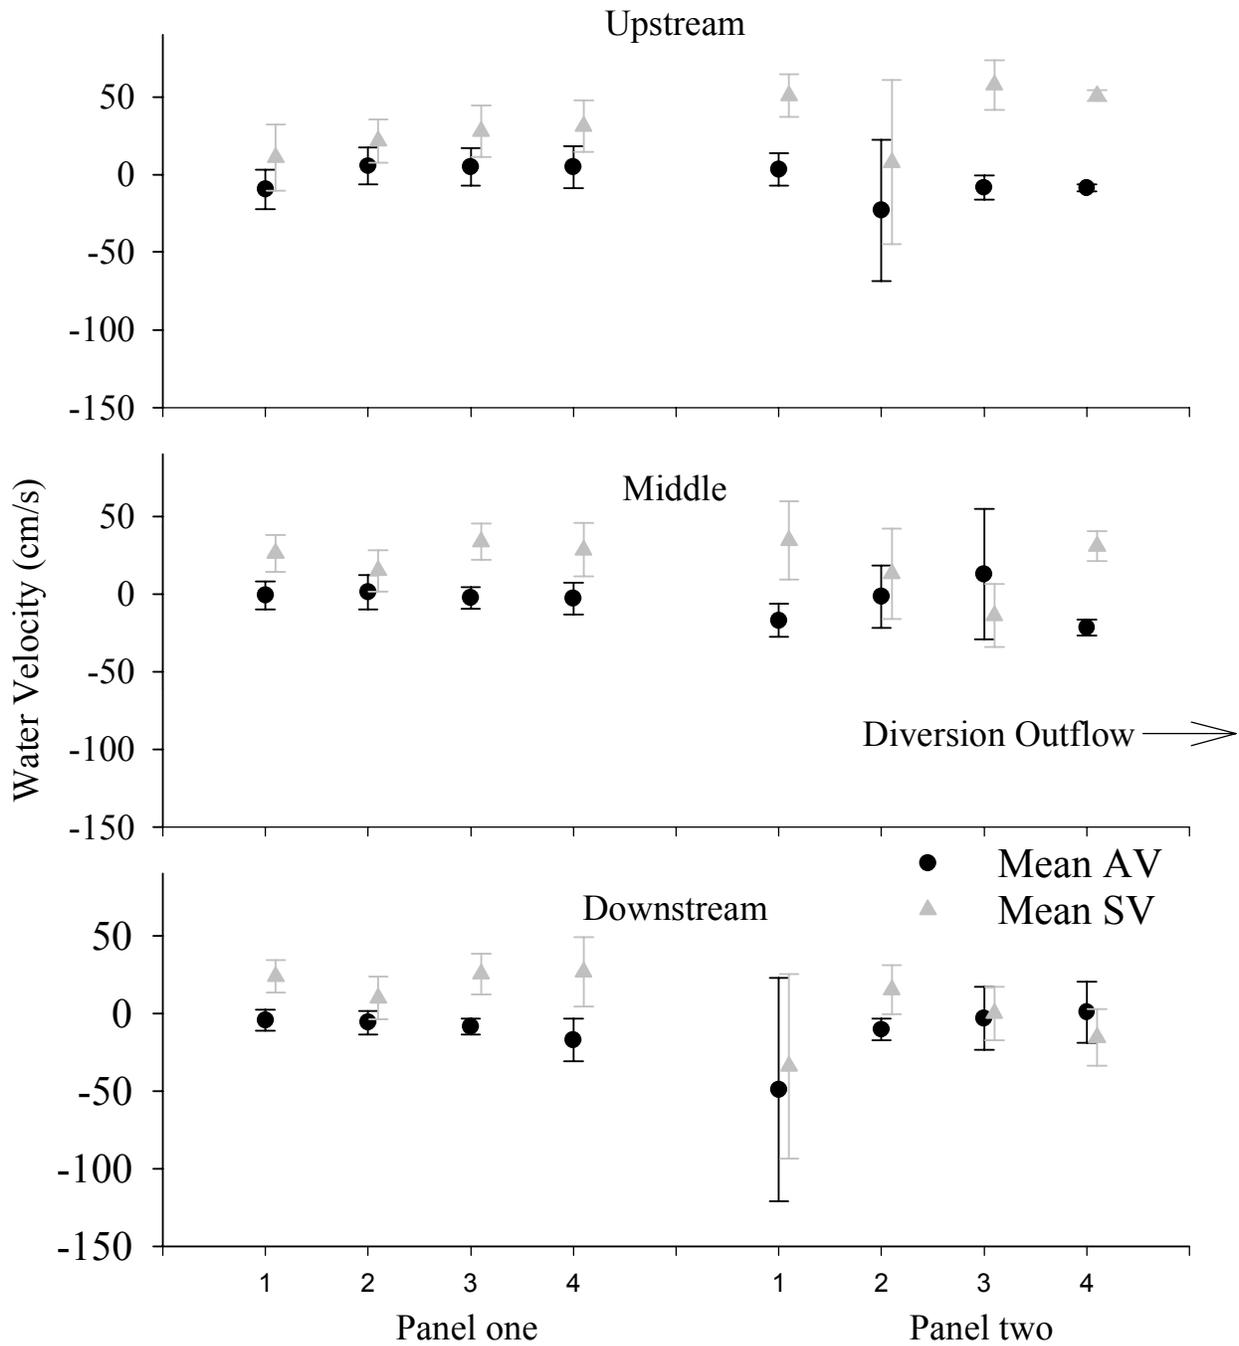
Figure 4. Mean (and SD) approach and sweeping velocities from the Malheur screen, a backwatered horizontal flat plate fish screen. Data were collected with an Acoustic Doppler Velocimeter from the front (upstream), middle, and rear (downstream) of two screen panels. Means were derived from 180 one second velocity measurements in the center of every 0.60 x 0.40 m section of screen area. All velocities on the left side of the graph came from one panel, those on the right came from the other. Withdrawal outflow was to the right of the graph.

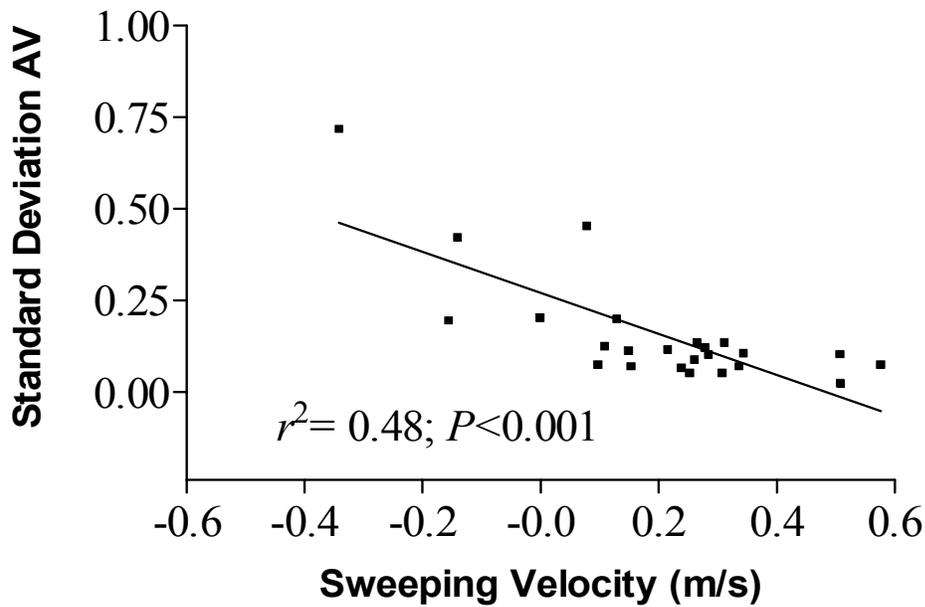
Figure 5. Simple linear regression of the standard deviation of approach velocity and the sweeping velocity in the center of several sections of the Malheur screen (top graph) and standard deviation of AV and SV (bottom graph). Data were derived by calculating descriptive statistics from 180 s of measurements from an Acoustic Doppler Velocimeter.

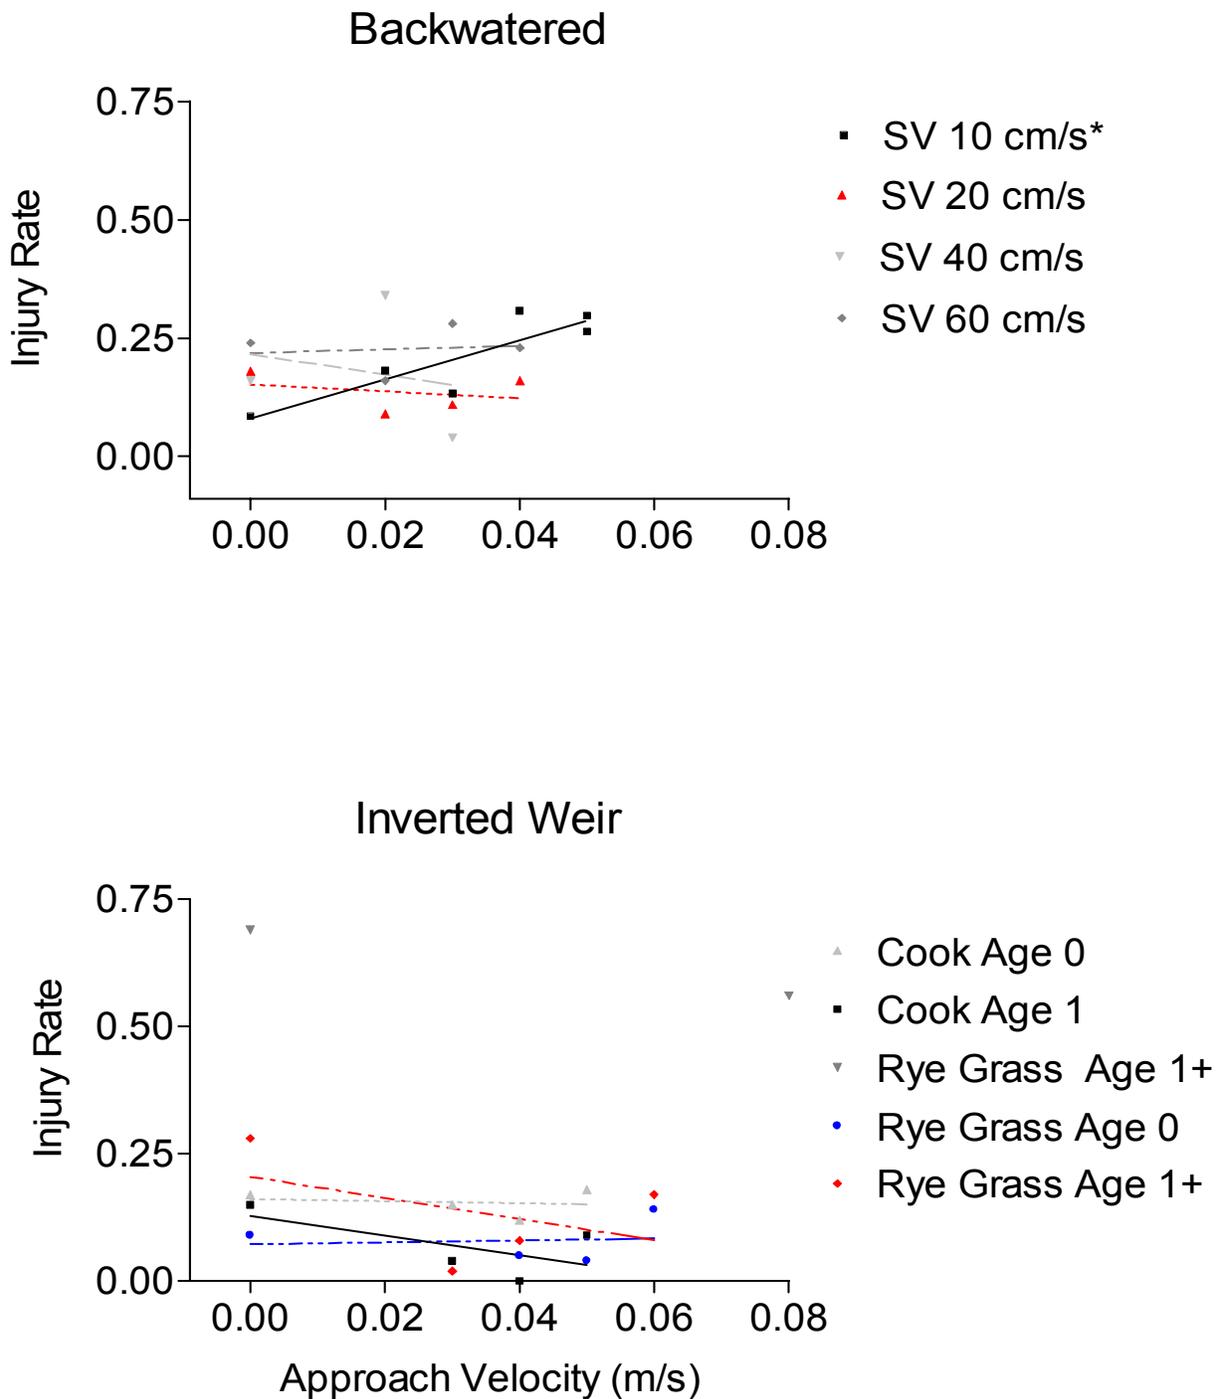
Figure 7. Relations between rate of injury and approach velocity for juvenile Redband rainbow trout experimentally released over two types of horizontal flat plate fish screens. Injury rate includes all injuries to the skin, eyes, and fins. Lines indicate the linear regression for various tests at different screens. An asterisk denotes a regression line that differed significantly from zero. SV = sweeping velocity. Approach velocities of zero were our control releases.

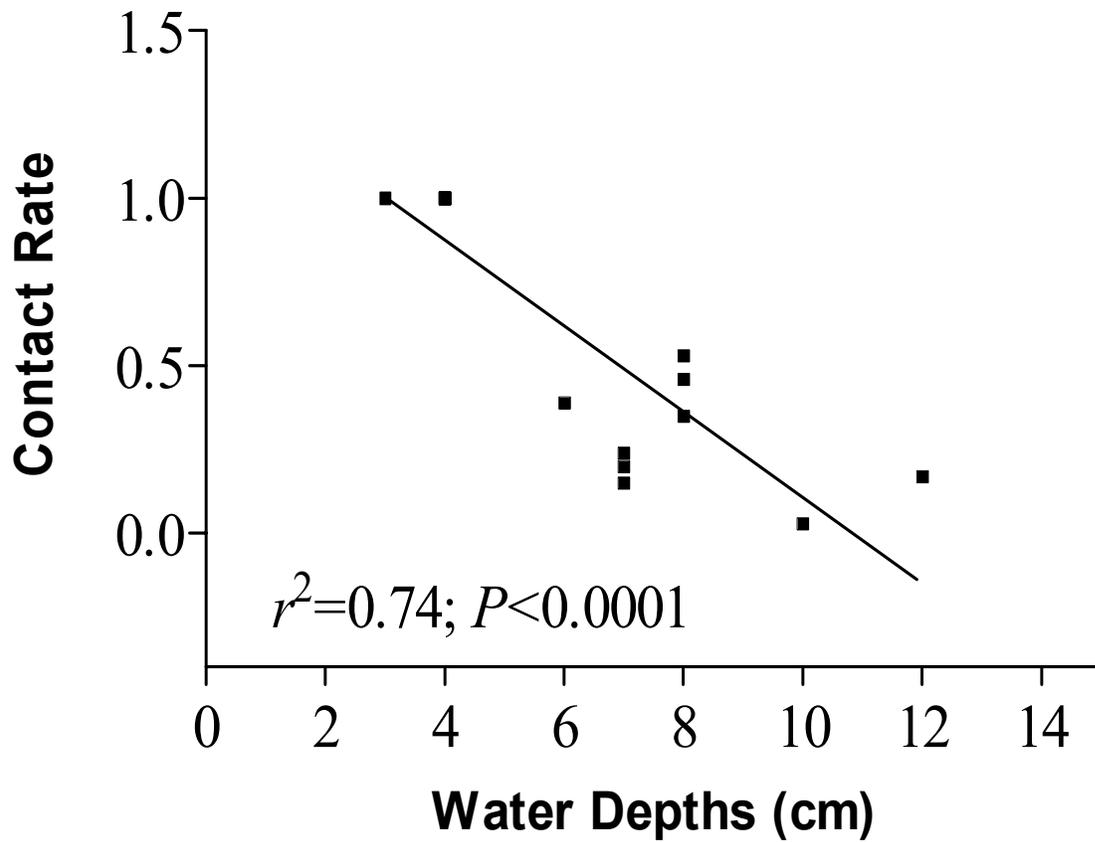
Figure 8. Relation between contact rate and water depth for fish released over inverted weir horizontal flat plate screens. Contact rates were derived by dividing the total number of times fish touched the screen by the number of fish viewed on underwater video tapes.

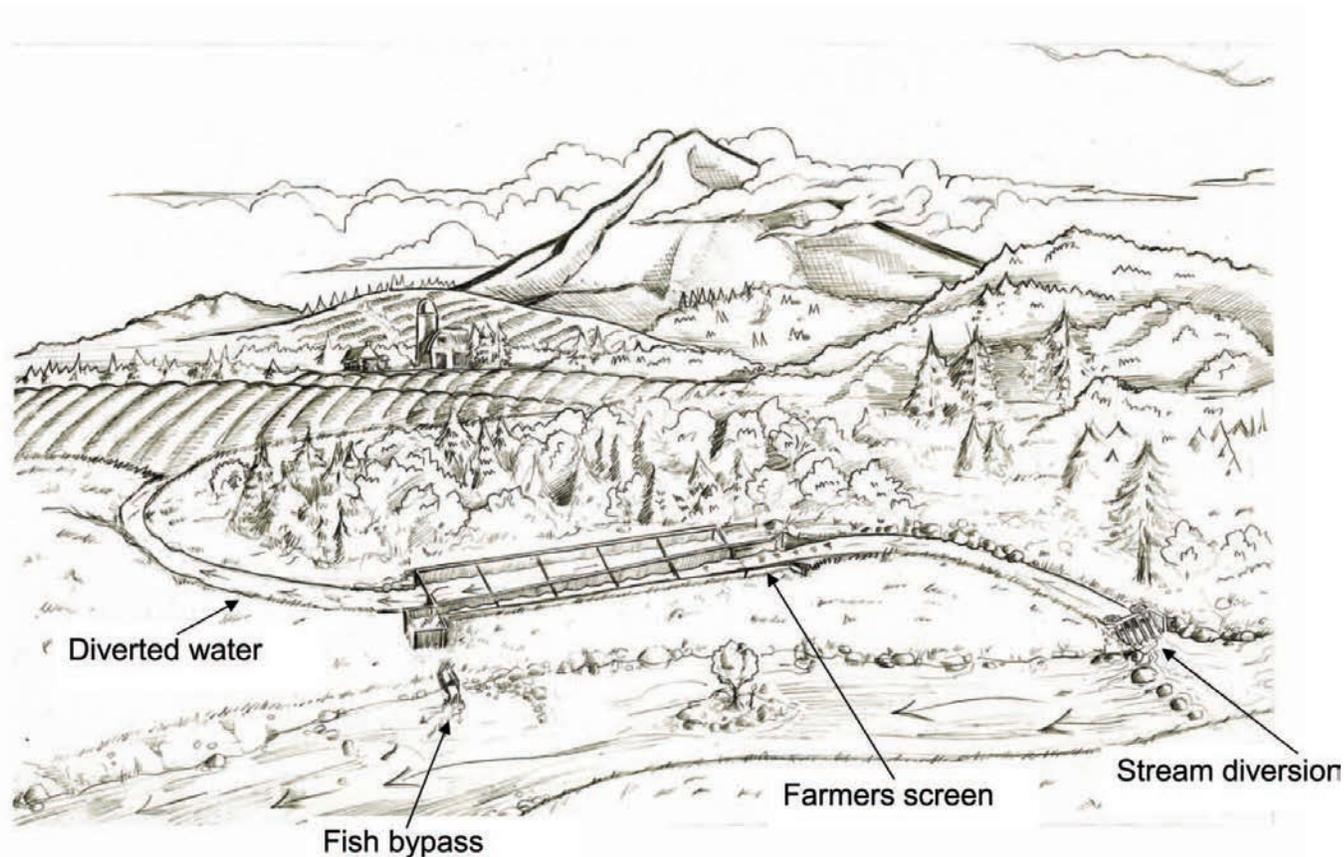
FIGURE 1. Conceptual drawing of a typical Farmers Screen installation (courtesy of the Farmers Conservation Alliance, Hood River, Oregon).

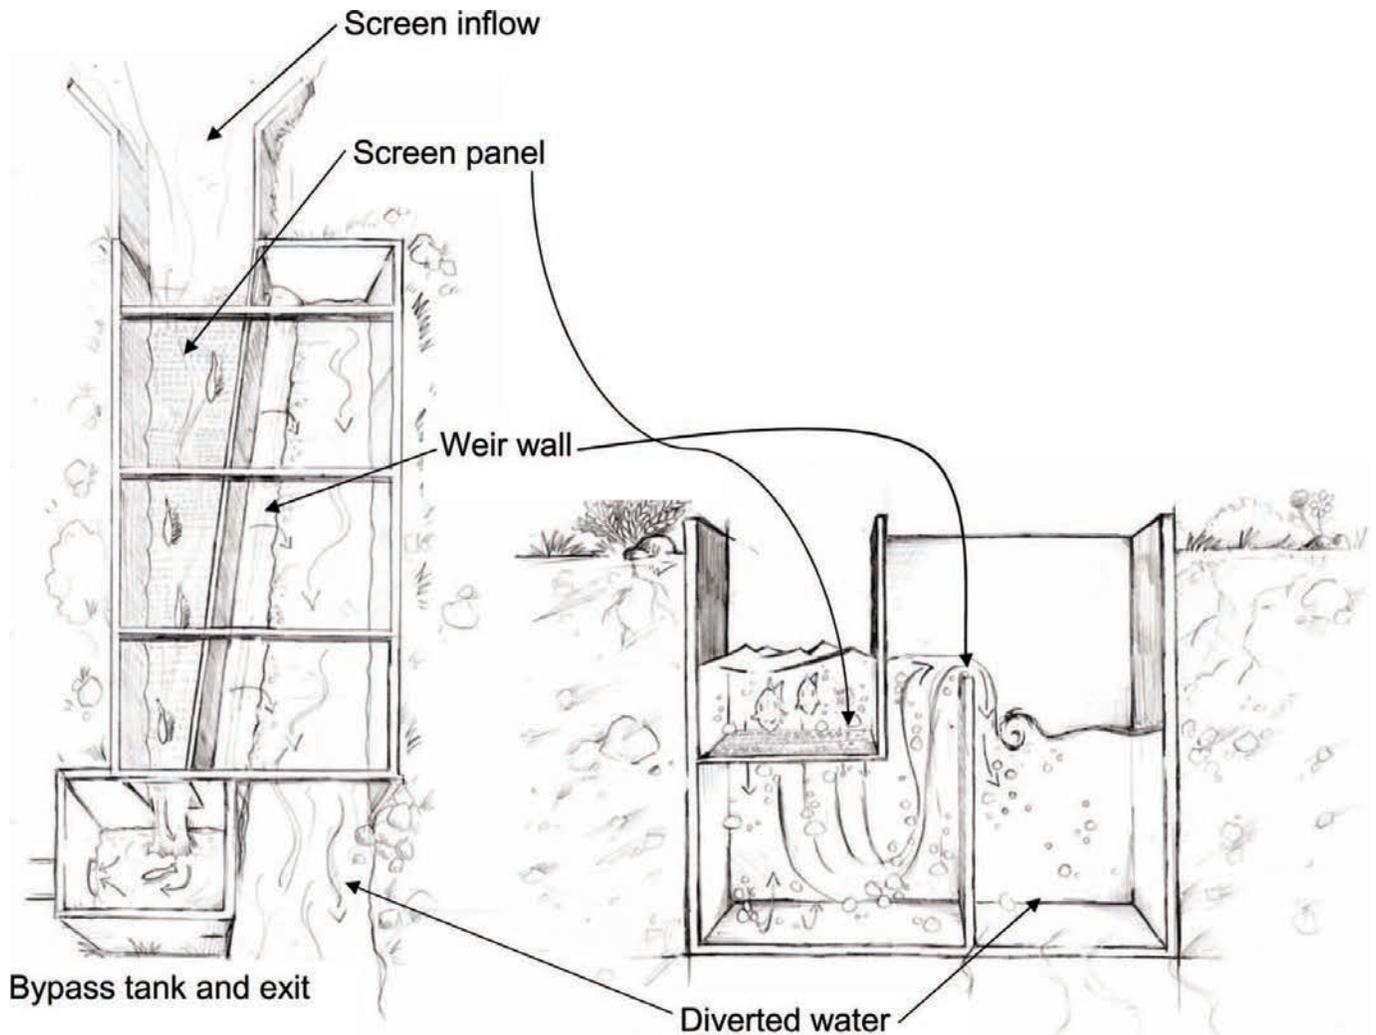
FIGURE 2. Conceptual overhead and frontal views of a typical Farmers Screen showing design details (courtesy of the Farmers Conservation Alliance, Hood River, Oregon).

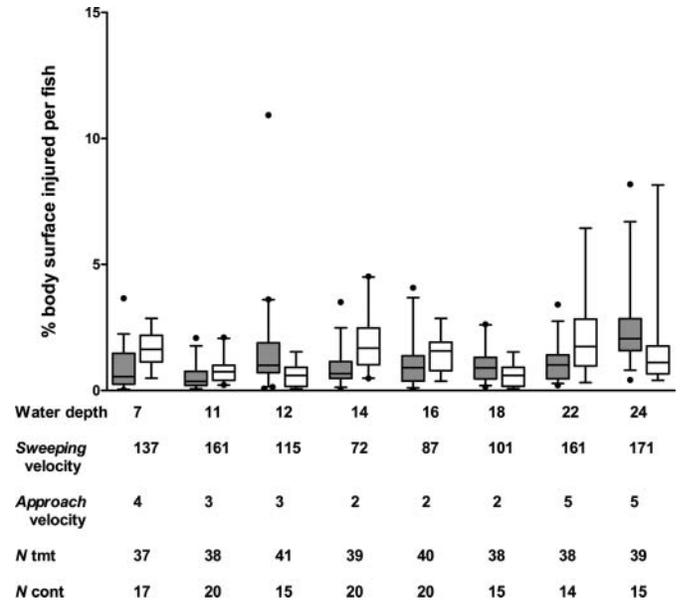
FIGURE 4. Box plots of percent body surface area injured for large (85–145 mm) juvenile coho salmon released over the Herman Creek screen (grey boxes) under different hydraulic conditions relative to control fish (white boxes). The upper and lower boundaries of the box represent the 25th and 75th quartiles, the horizontal line inside the box is the mean, the whiskers represent the 5% and 95% confidence intervals, and outliers are shown by solid points. The x-axis shows the water depth over the screen (cm), the mean sweeping velocity (cm/s), the approach velocity (cm/s), and the number of treatment (tmt) and control (cont) fish tested during each trial. Differences between medians within a group were significant for all tests (Mann–Whitney *U*-tests, $P < 0.05$).

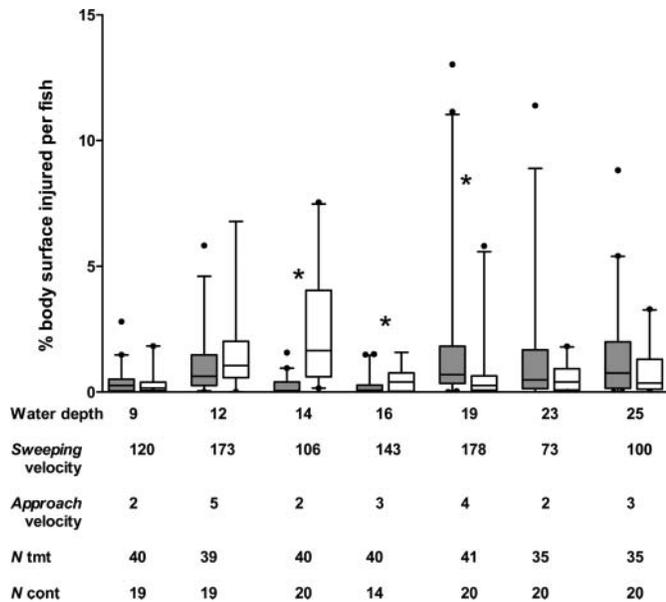
FIGURE 5. Box plots of percent body surface area injured for small (54–78 mm) juvenile coho salmon released over the Herman Creek screen (grey boxes) under different hydraulic conditions relative to control fish (white boxes). Box plot descriptions and x-axis labels are as defined in the caption for Figure 4. Differences between medians within a group are denoted by an asterisk (Mann–Whitney U -tests, $P < 0.05$).
